The Commonwealth of Massachusetts

DEPARTMENT OF PUBLIC UTILITIES

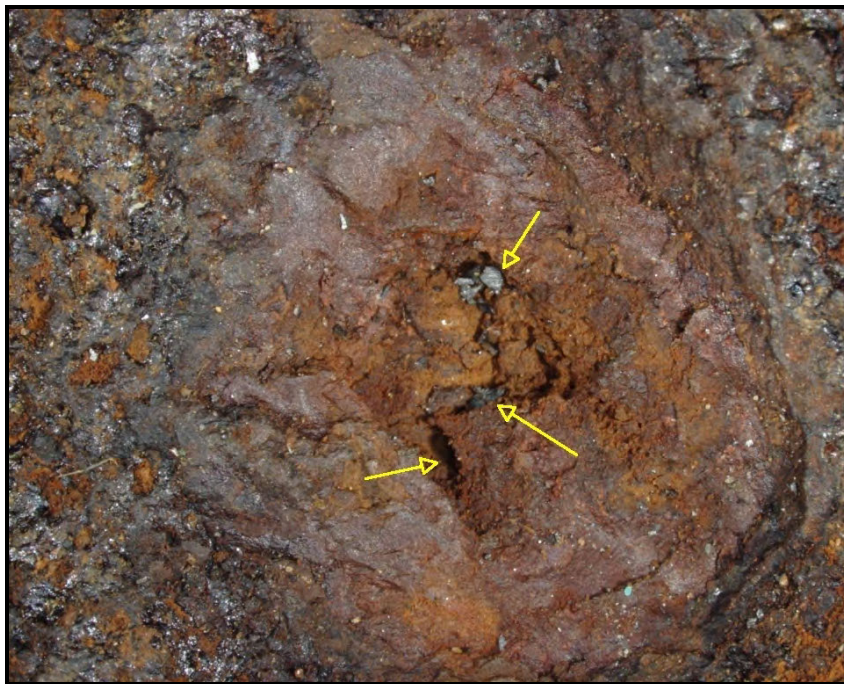
Figure 61: Failed location at 4 o'clock: An overall view of the corroded spot on OD.

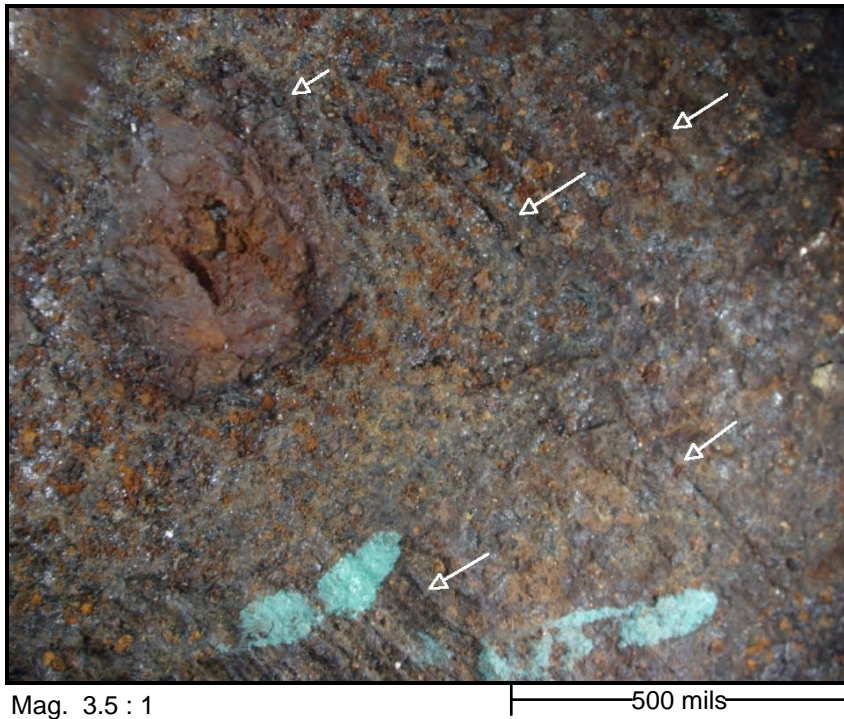
Figure 63: Failed location at 4 o'clock: An overall view of the corroded spot on OD. Arrows point to parallel line type surface impression around the corroded spot.

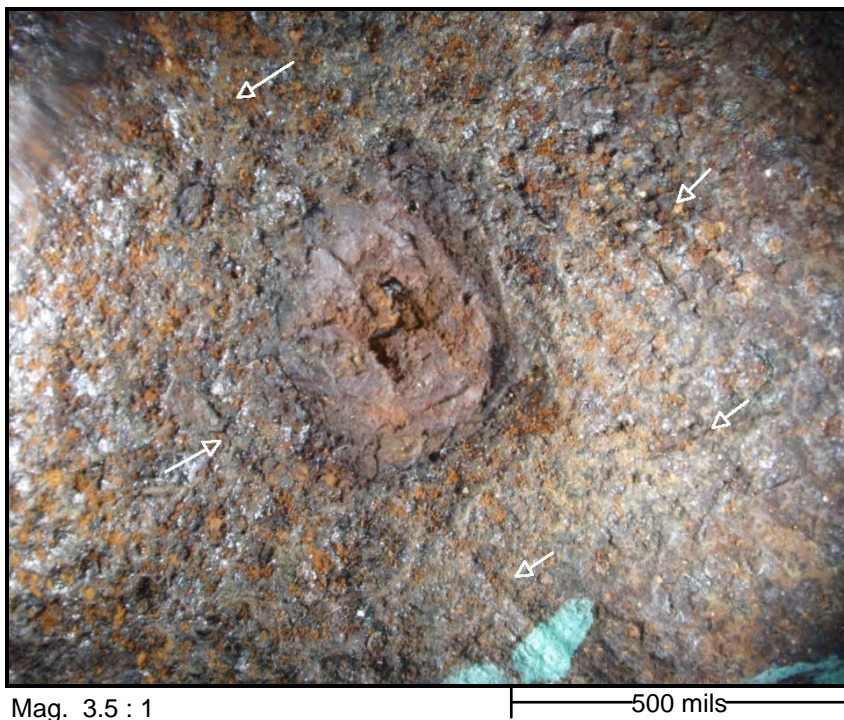
Figure 64: Failed location at 4 o'clock: An overall view of the corroded spot on OD. Arrows point to parallel line type surface impression around the corroded spot. Another view.

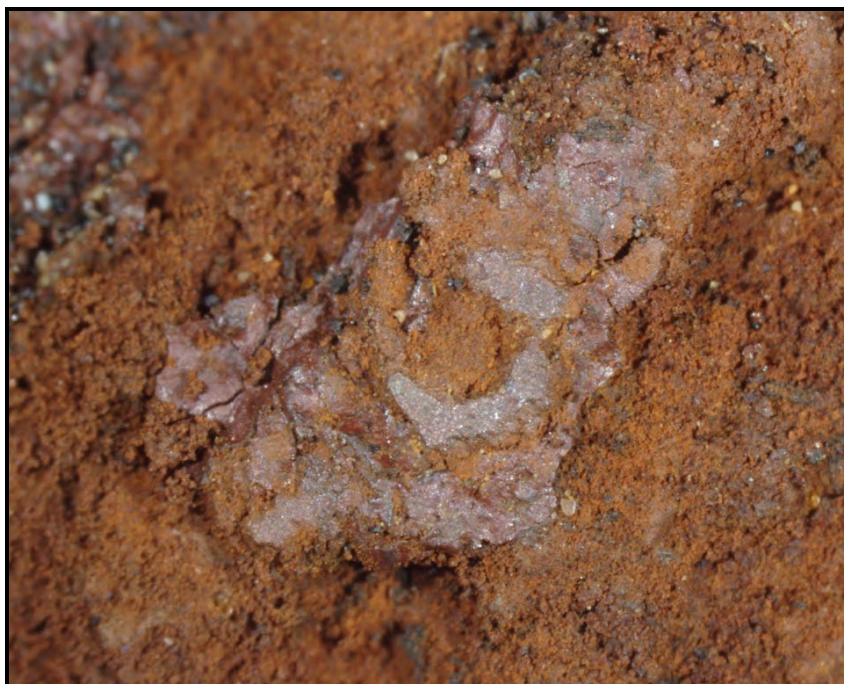
Figure 65: Failed location at 4 o'clock: An overall view of the corroded spot on ID. Note the packed corrosion debris.

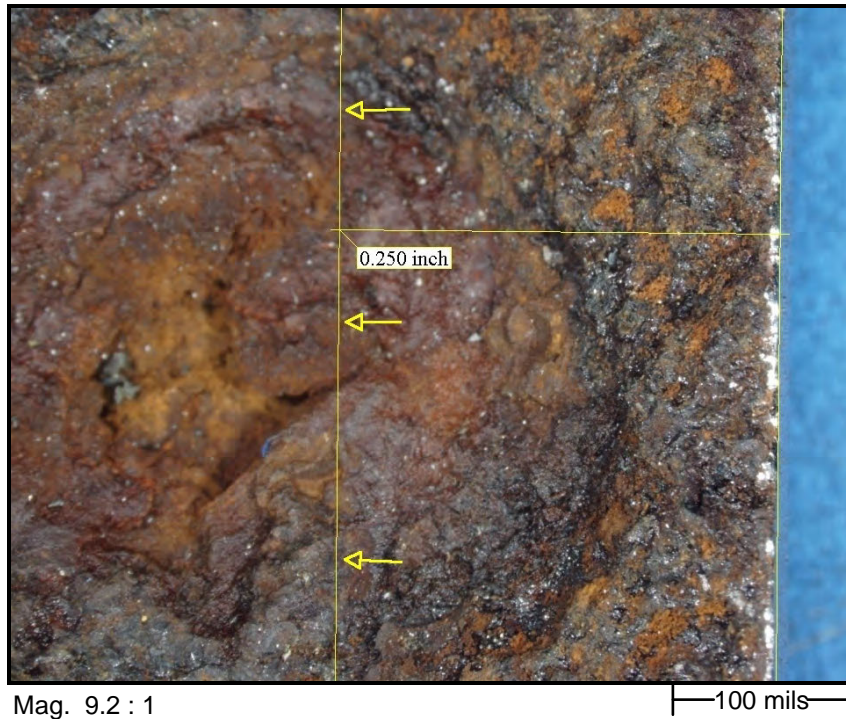
Figure 67: 4 o'clock anomaly: Arrows point to the mounted plane.

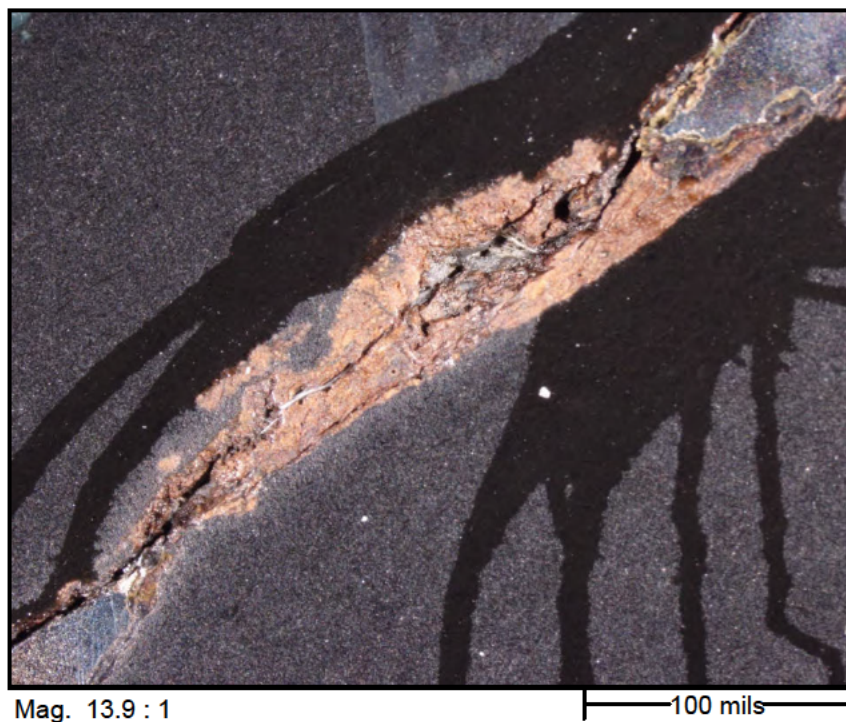
Figure 91: 4 o'clock: An overall view of the mounted cross-section. A higher magnification view of the corrosion debris tightly packed in the pit.

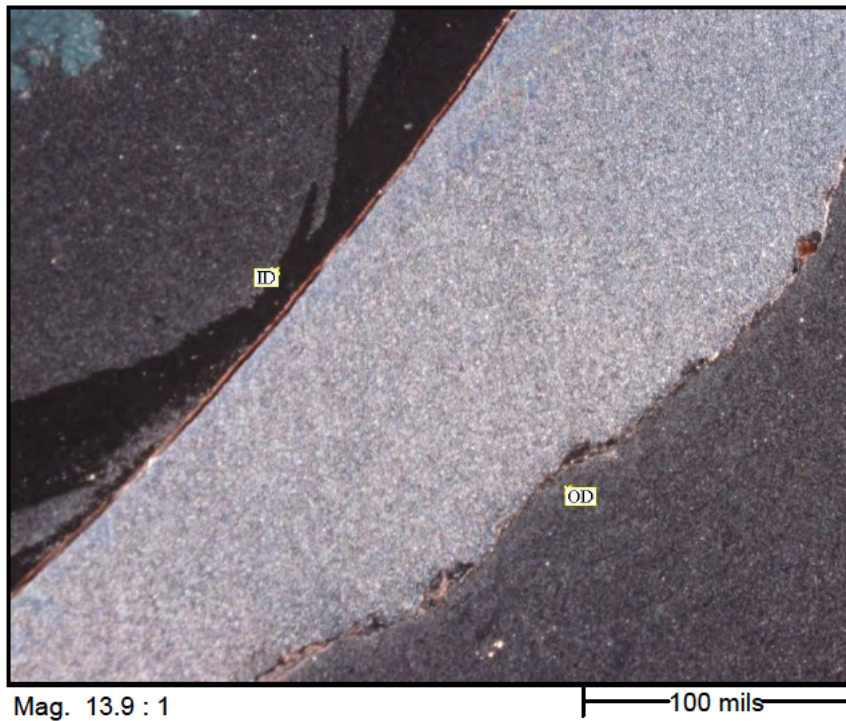
Figure 92: 4 o'clock: An overall view of the mounted cross-section. Note general corrosion on the OD. On the ID a reddish coating layer is present; no corrosion on the ID.

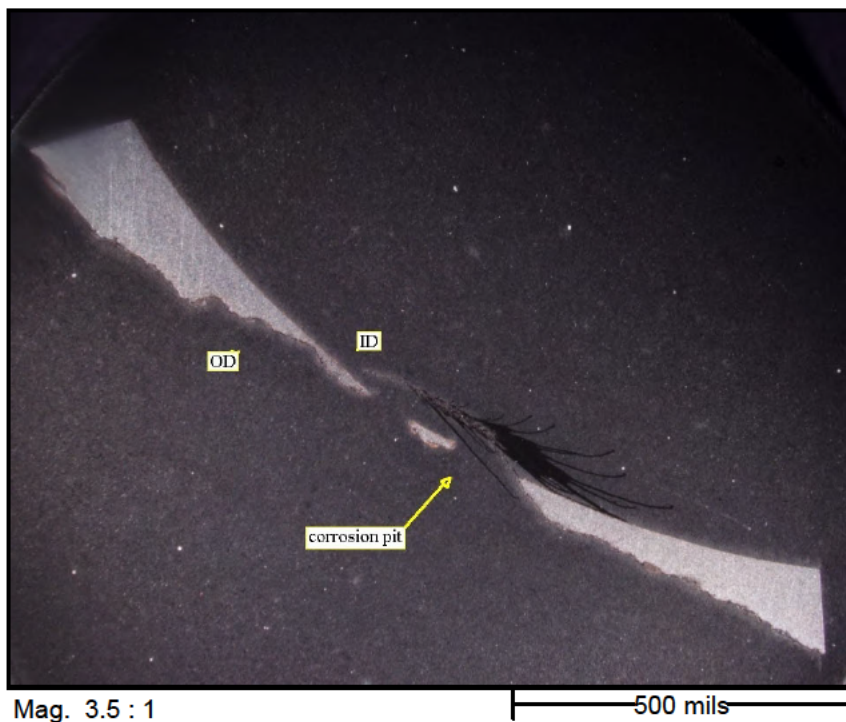
Figure 93: 7 o'clock: An overall view of the mounted cross-section.

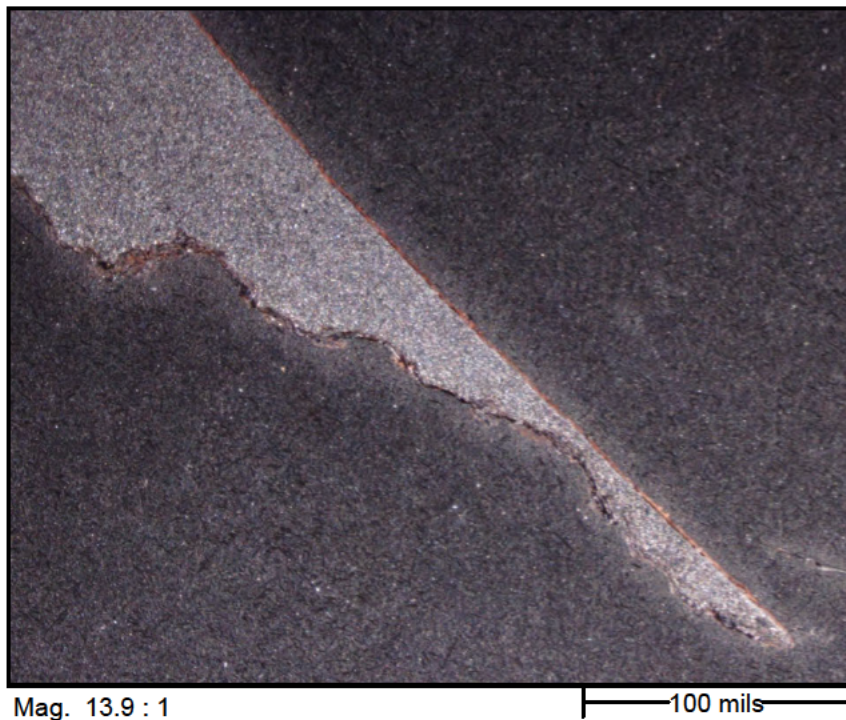
Figure 95: 7 o'clock: An overall view of the mounted cross-section. A higher magnification view of the pit edge. Note the general wall thinning due to corrosion on the tube from the OD and reduction of the wall to knife edge.

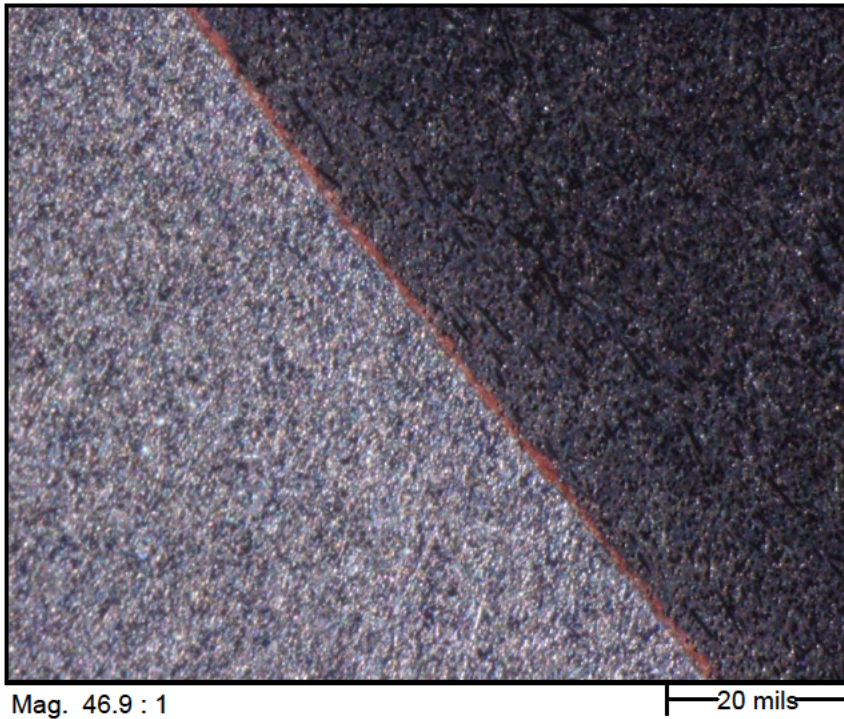
Figure 96: 7 o'clock: Note the reddish paint layer on the ID and no corrosion.

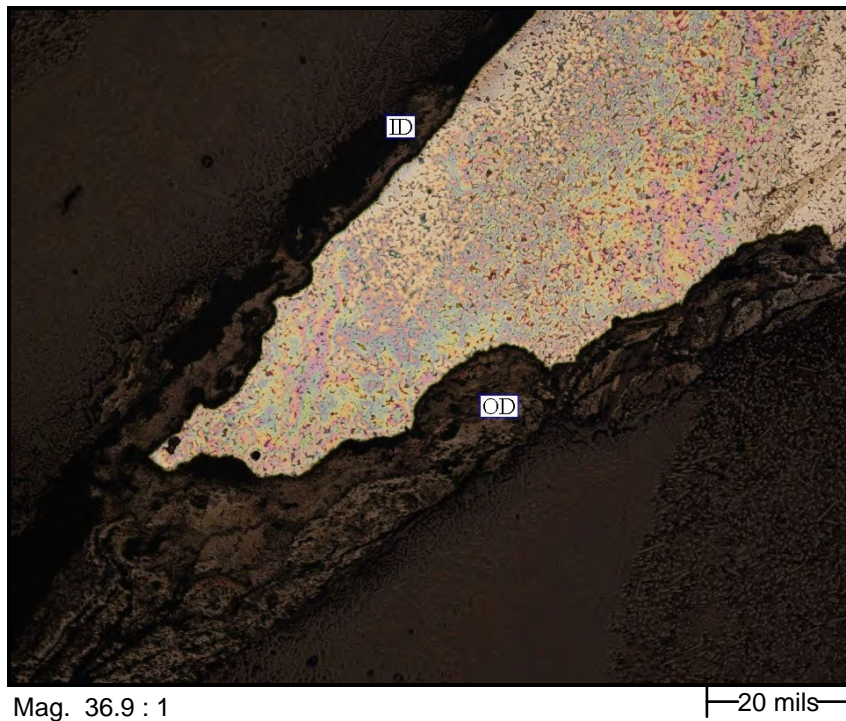
Figure 97: Mount at 4 o'clock: the view shows an edge of the through wall corrosion pit.

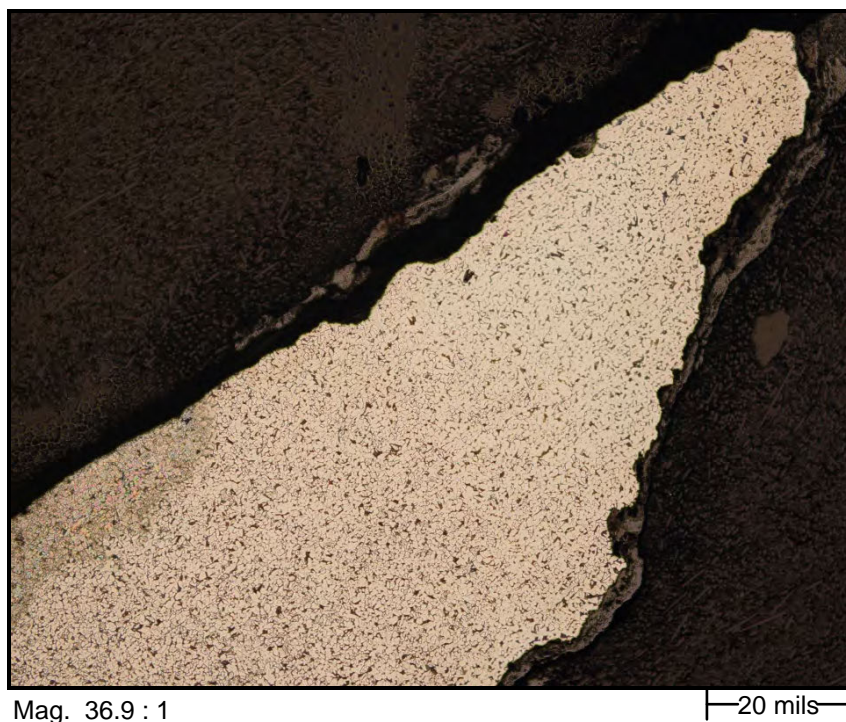
Figure 98: Mount at 4 o'clock: the view shows the opposite edge of the through wall corrosion pit.

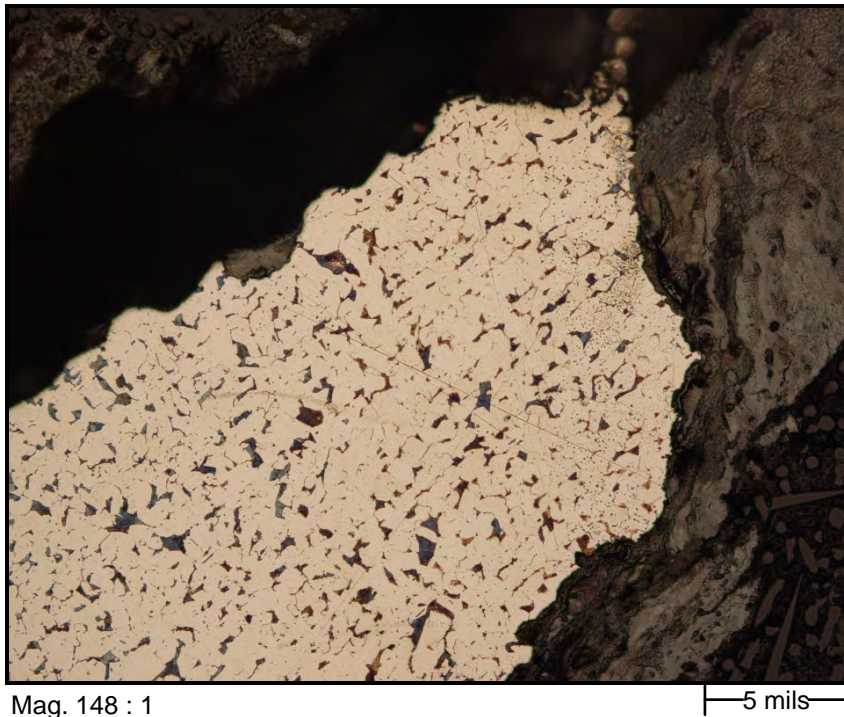
Figure 99: Mount at 4 o'clock: the view shows the opposite edge of the through wall corrosion pit. A higher magnification view of the previous image showing the microstructure.

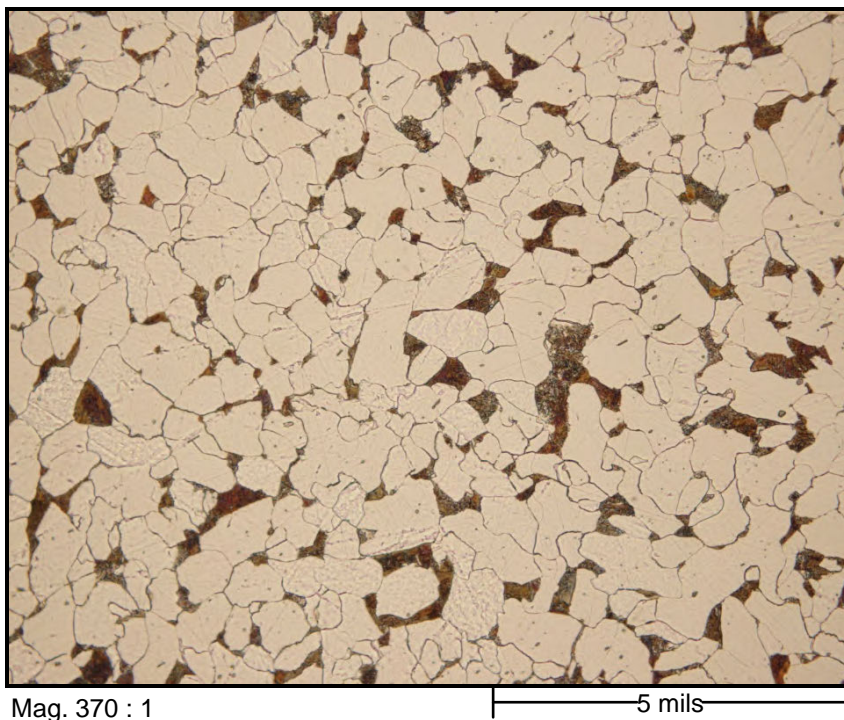
Figure 100: Mount at 4 o'clock: A representative view of the microstructure.

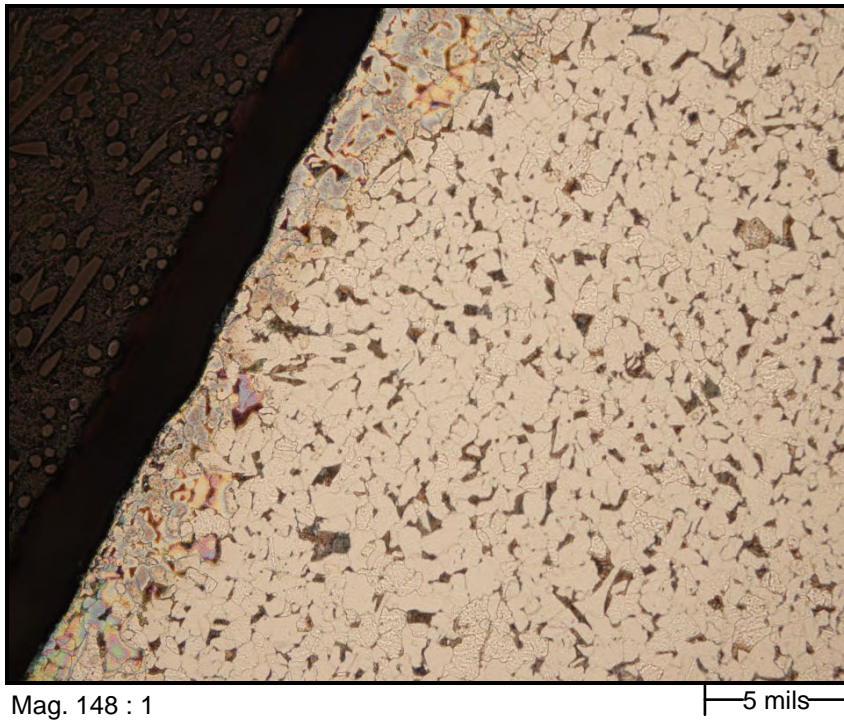
Figure 101: Mount at 4 o'clock: The ID of the tube shows no corrosion.

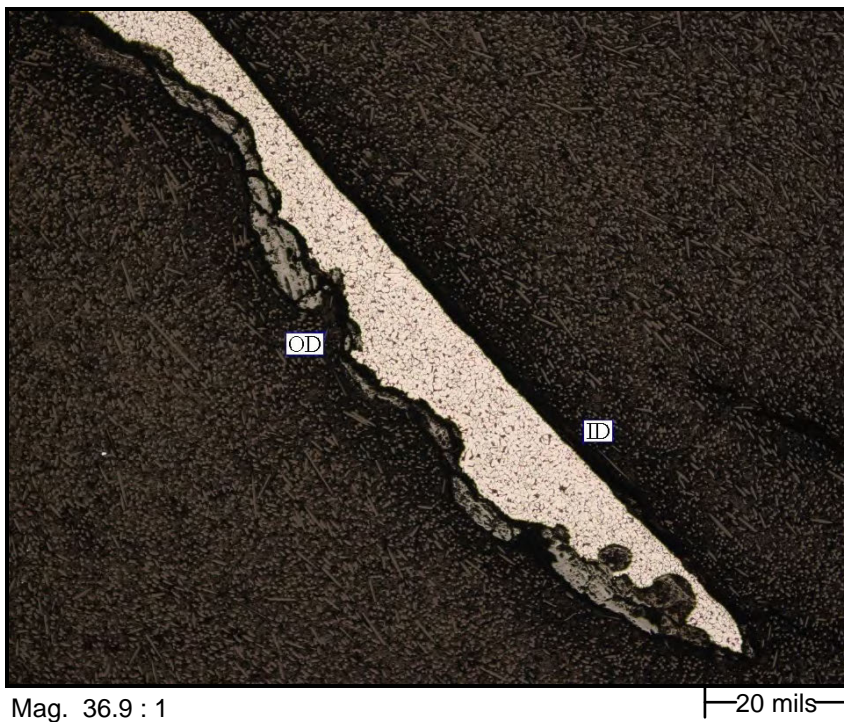
Figure 102: Mount at 7 o'clock: the view shows an edge of the through wall corrosion pit.

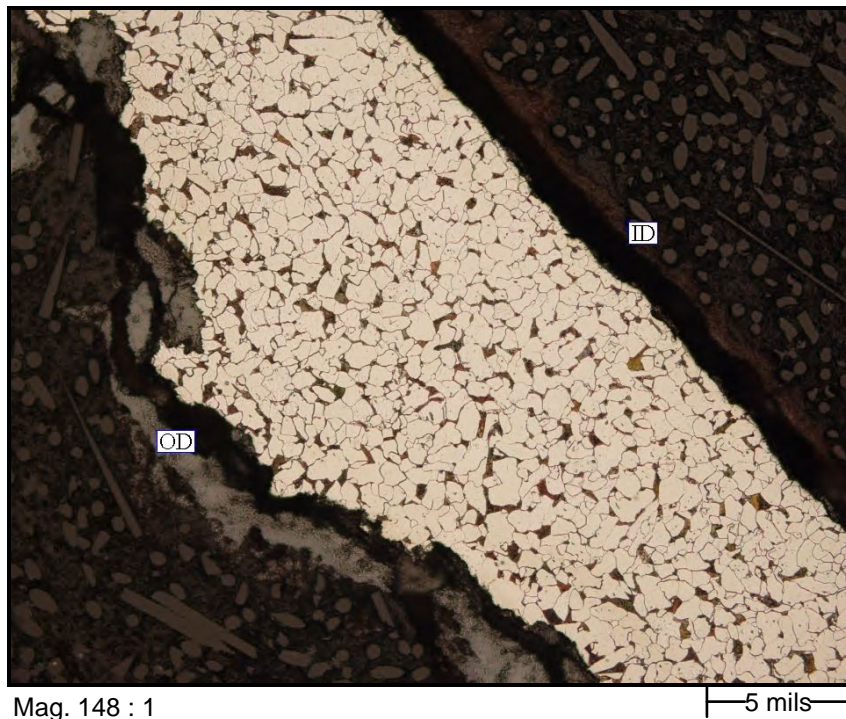
Figure 103: Mount at 7 o'clock: the view shows general corrosion attack on the OD. No corrosion noted on the ID.

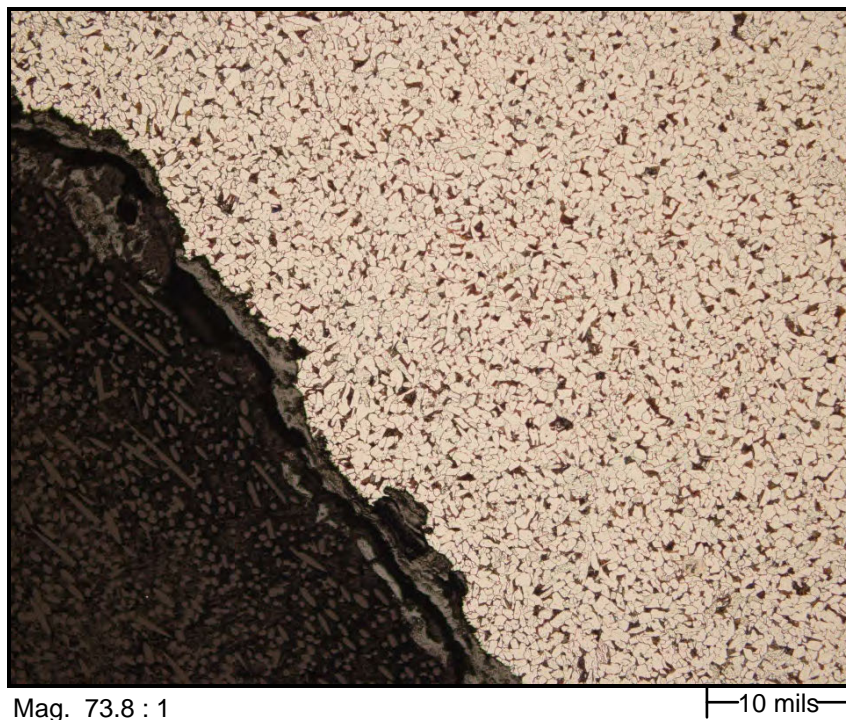
Figure 104: Mount at 7 o'clock: the view shows general corrosion attack on the OD.
