**CAROL A. SHARRIGAN, AS PERSONAL
REPRESENTATIVE OF THE ESTATE OF
GREG J. SHARRIGAN,**
Plaintiff,

**EVERSOURCE ENERGY, and NSTAR
GAS COMPANY d/b/a EVERSOURCE
ENERGY,**

COMPLAINT AND JURY DEMAND

7. At approximately 4:14 p.m. on Thursday, September 2, 2021, a natural gas explosion destroyed a single-family home at 27 Park Street in Maynard, Middlesex County, Commonwealth of Massachusetts. The force of the blast sent the home's windows into the street, caused a significant structure fire, and killed Greg Sharrigan.

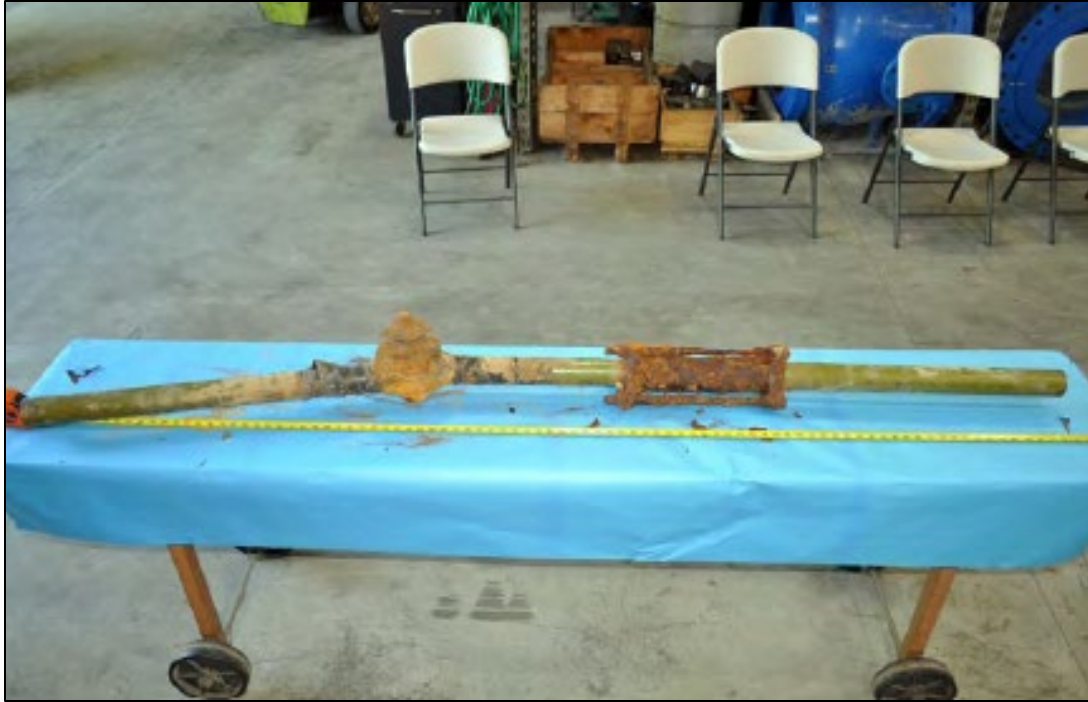
79. **Exhibit L**, the MMR report, shows the removed section of pipe and leaking coupling from outside the Sharrigan home:

80. In her investigation, MMR's Director of Materials Engineering, Fahmida Hossain, Ph.D., identified corrosion on the metal coupling.
81. The corrosion and the hole in the pipe are visible without magnification.

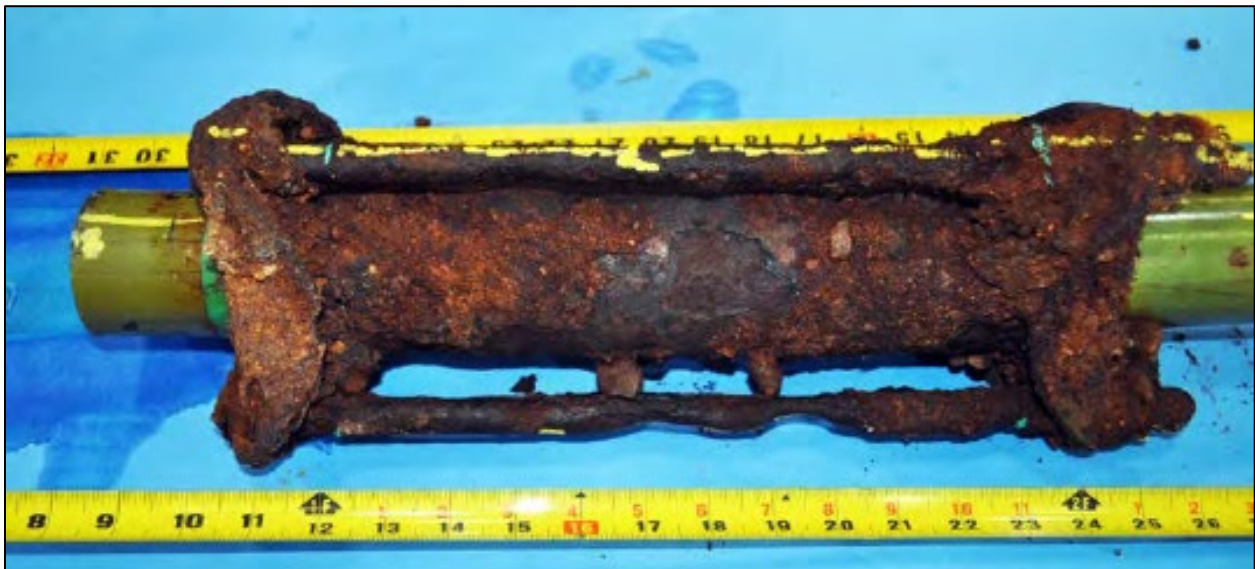
89. Exhibit L contains the below picture of the corroded coupling of the failed gas main that serviced the Sharrigan house.

90. The corrosion led to pitting in the metal, breaching the pipe wall, allowing gas to escape into the ground.

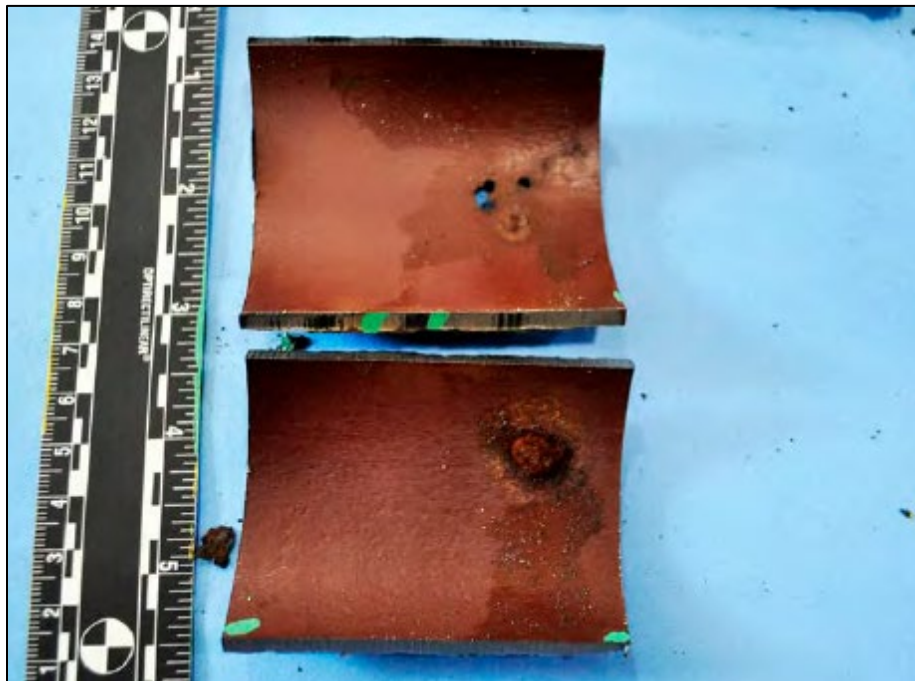
91. **Exhibit L** contains the below shows a cross-section of the leaking segment of the corroded coupling of the failed gas main that serviced the Sharrigan house. Note the multiple visible holes.

92. MMR concluded that the mechanical coupling had visible significant corrosion on the entire outer diameter of the coupling.

93. MMR concluded that there were two separate leaks caused by corrosion extending from inside to outside in the coupling that caused the gas to leak and caused the explosion.

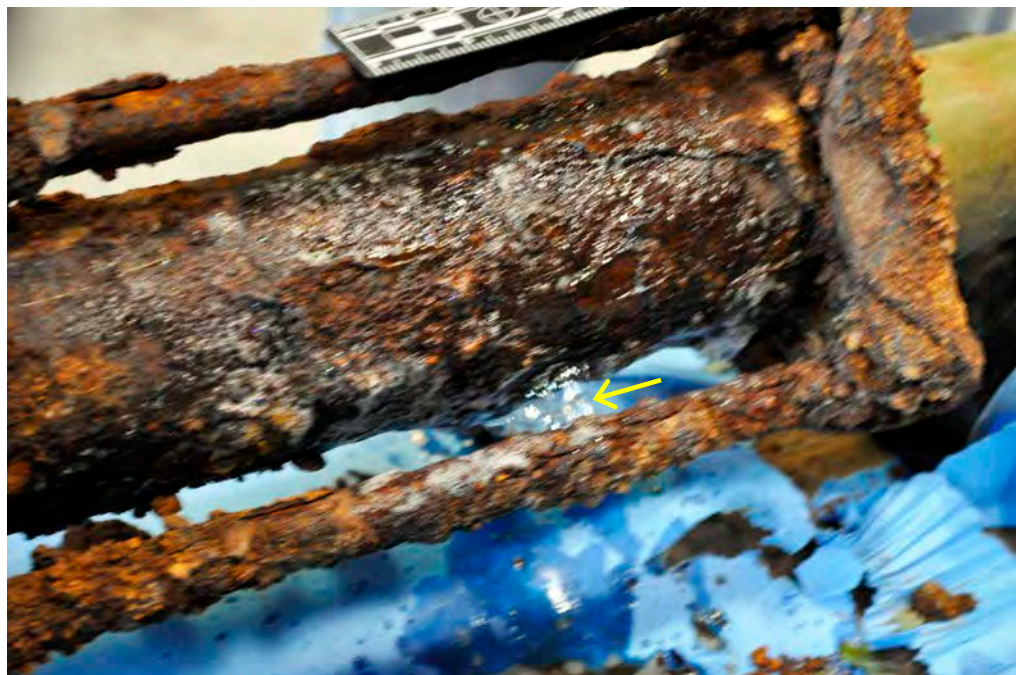
Figure 19: Arrow points to a leaking location @ ~7 o'clock on the coupling.

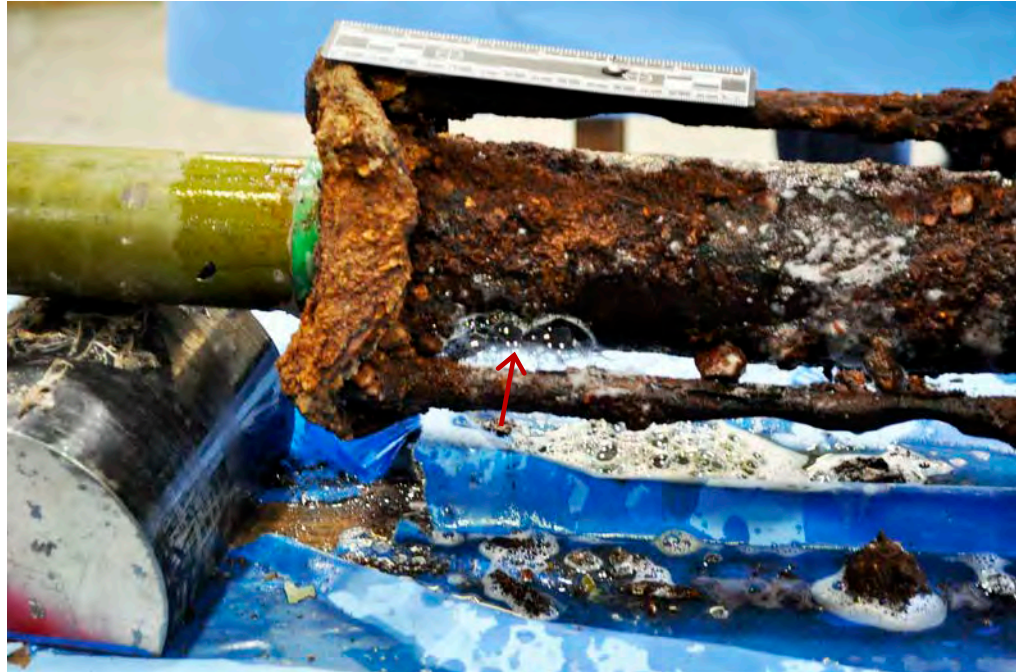
Figure 20: Another view of the leaking location, arrow.

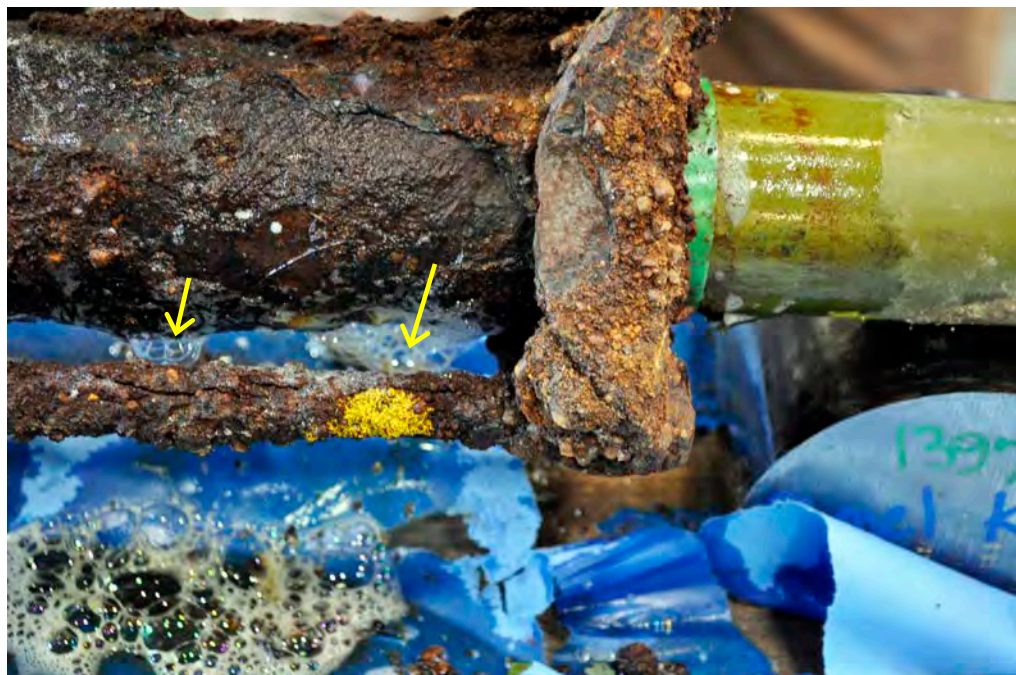
Figure 21: Another view of the leaking areas.

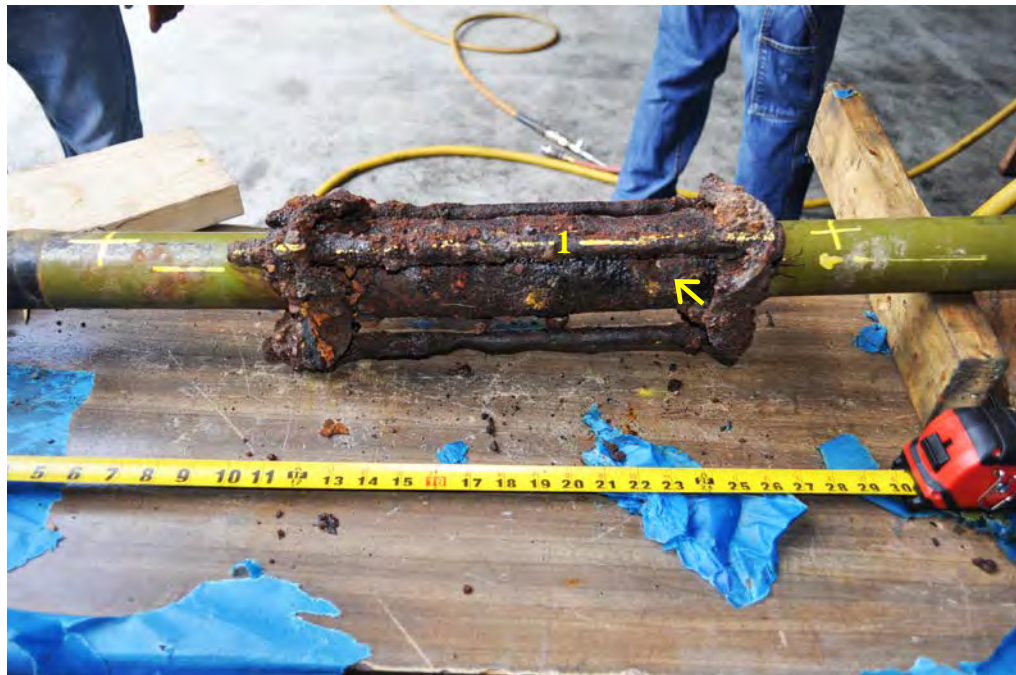
Figure 23: Arrow points to the 7 o'clock leak. Yellow lengthwise lines are witness lines. The cross-lines are cut lines.

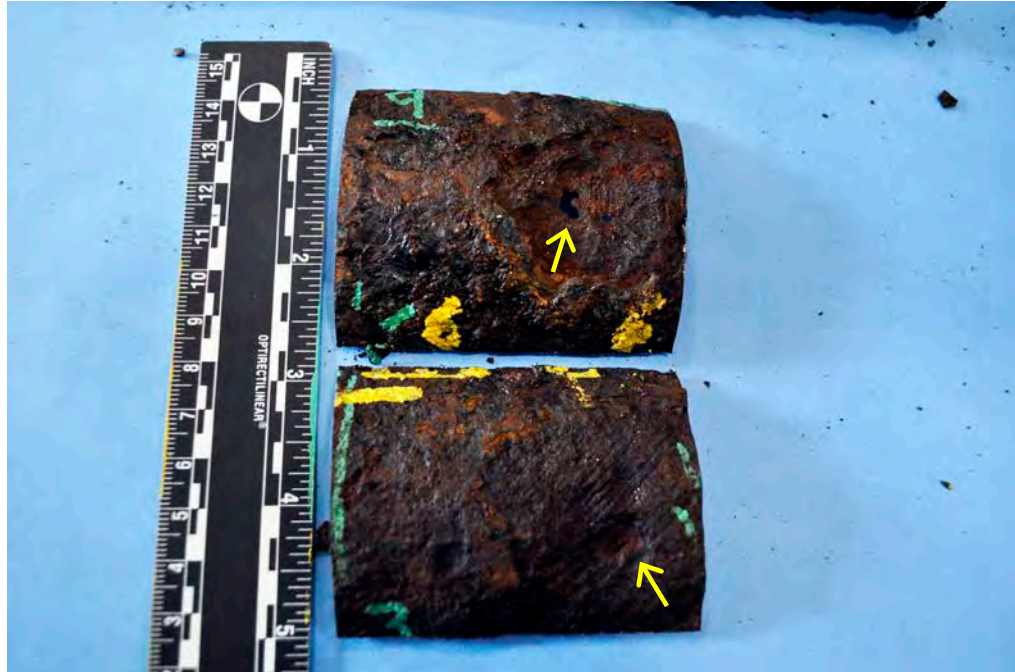
Figure 50: Arrows point to 7 o'clock leak (top) and a possible leak @ 4 o'clock (bottom).

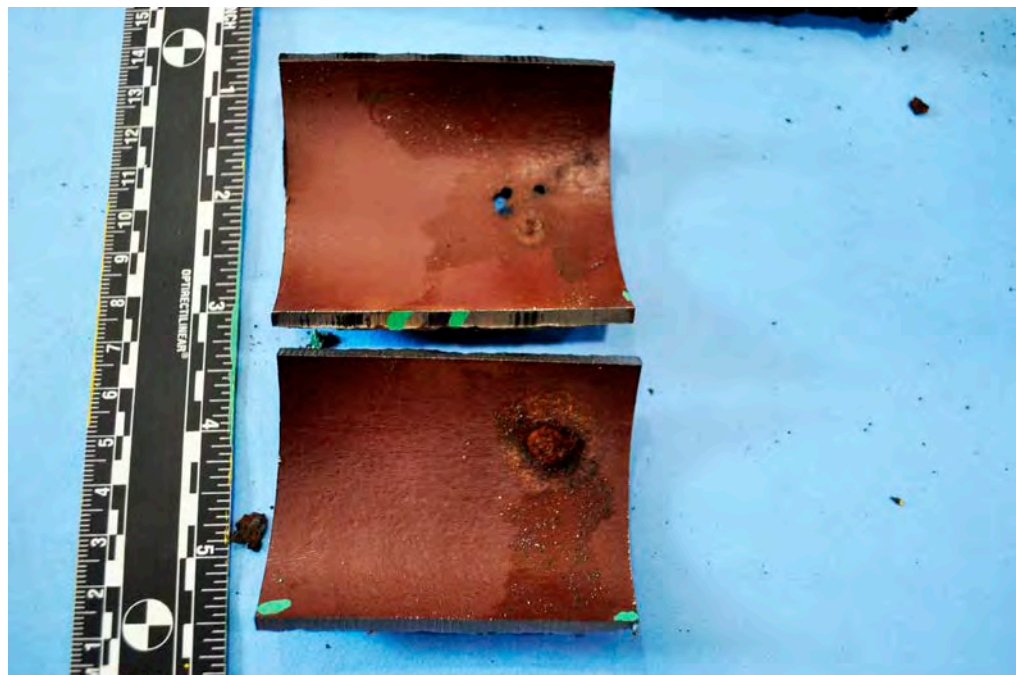
Figure 53: ID view: 7 o'clock through hole pits (top) and 4 o'clock possible leak (bottom)

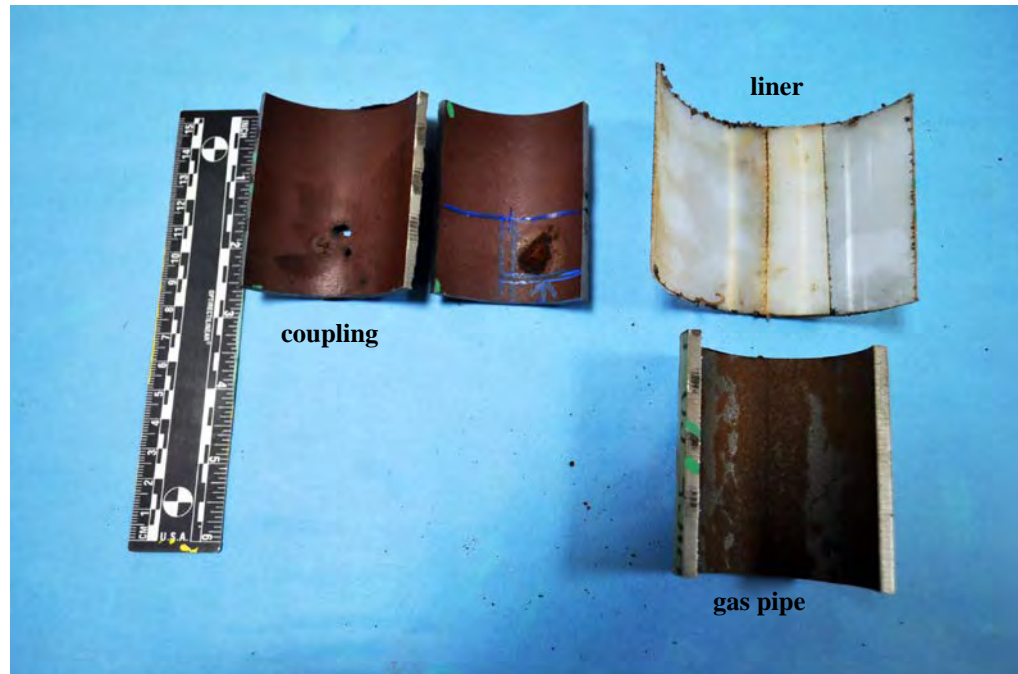
Figure 54: ID view of the components in the leaking segment.

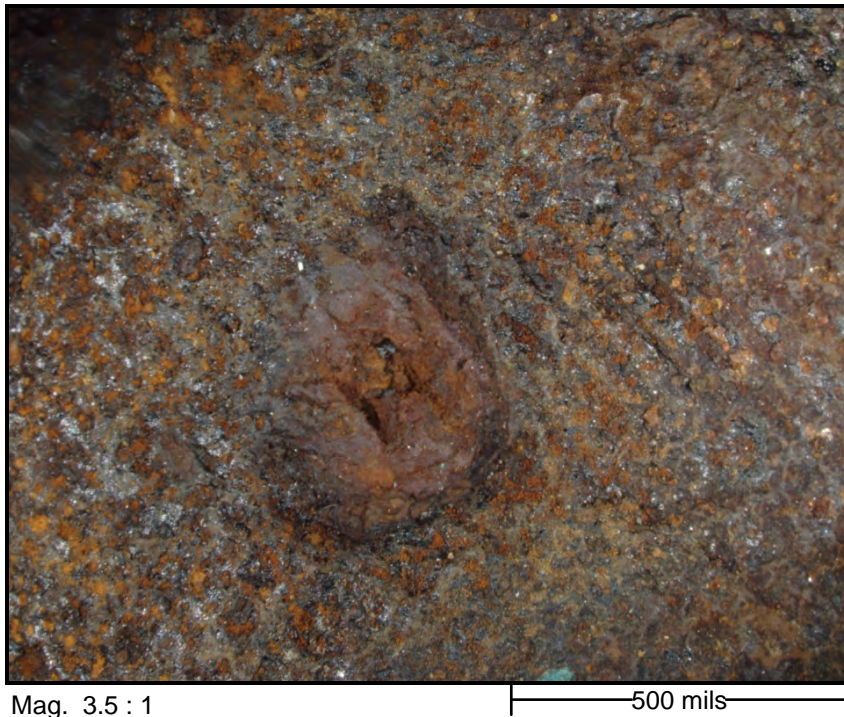
Figure 61: Failed location at 4 o'clock: An overall view of the corroded spot on OD.

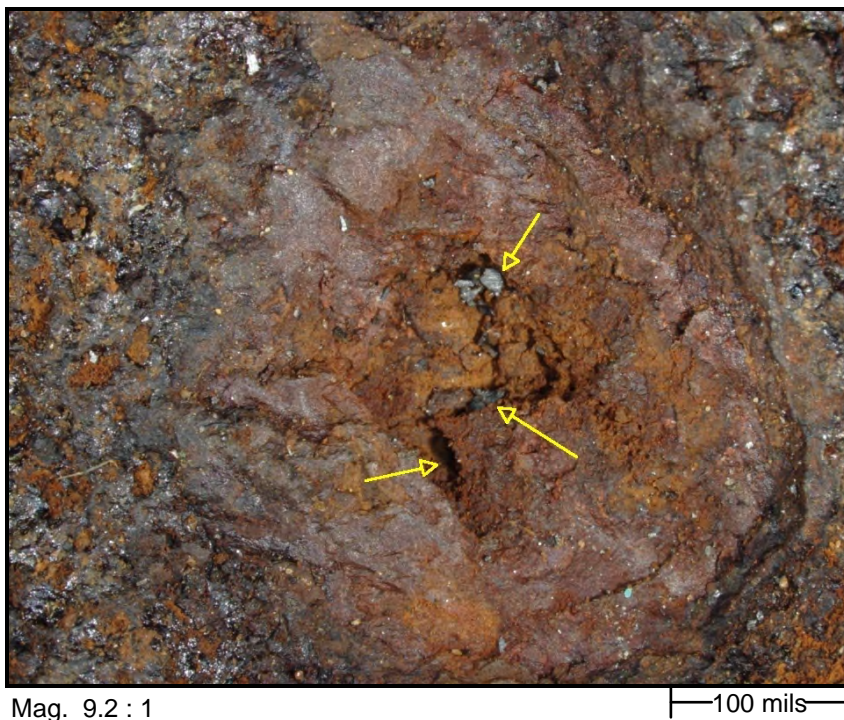
Figure 62: Failed location at 4 o'clock: An overall view of the corroded spot on OD. A higher magnification view of the previous image. Arrows point to possible through wall corrosion.

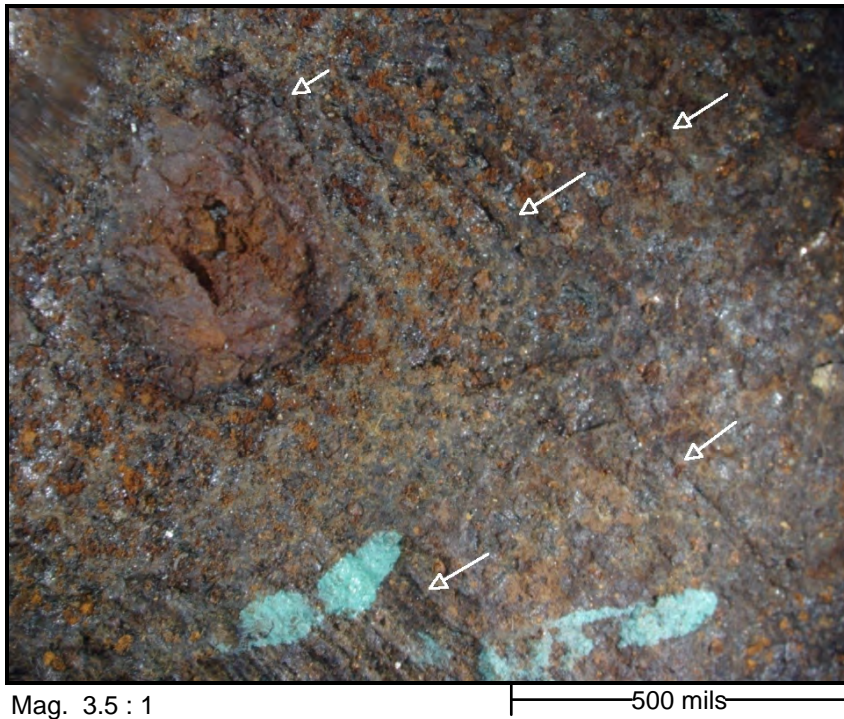
Figure 63: Failed location at 4 o'clock: An overall view of the corroded spot on OD. Arrows point to parallel line type surface impression around the corroded spot.

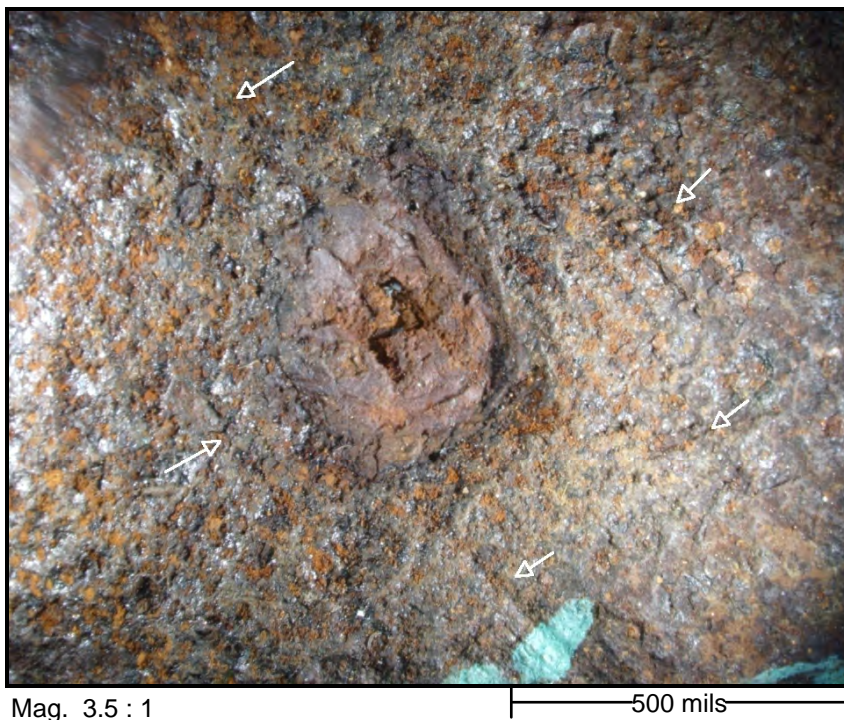
Figure 64: Failed location at 4 o'clock: An overall view of the corroded spot on OD. Arrows point to parallel line type surface impression around the corroded spot. Another view.

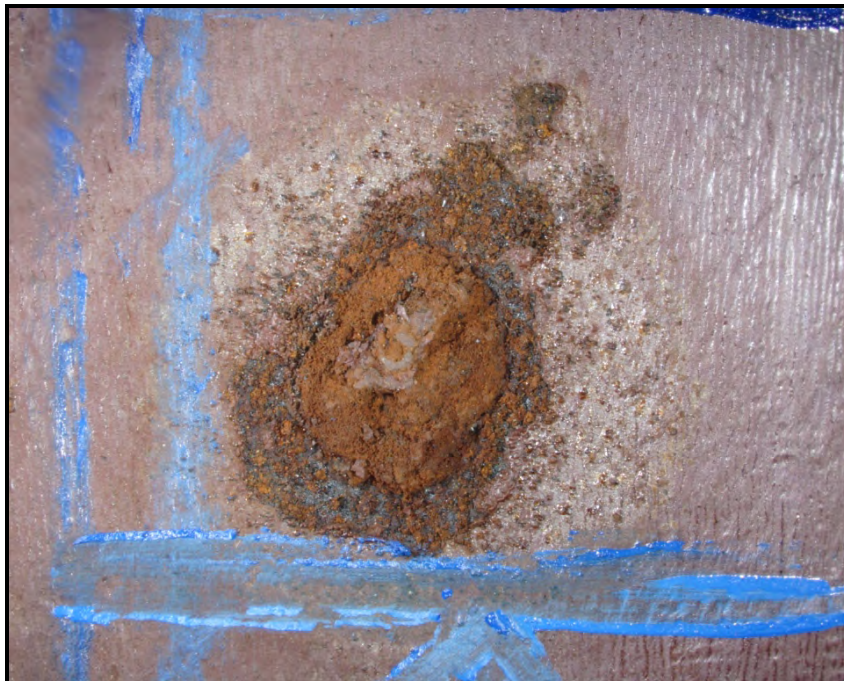
Figure 65: Failed location at 4 o'clock: An overall view of the corroded spot on ID. Note the packed corrosion debris.

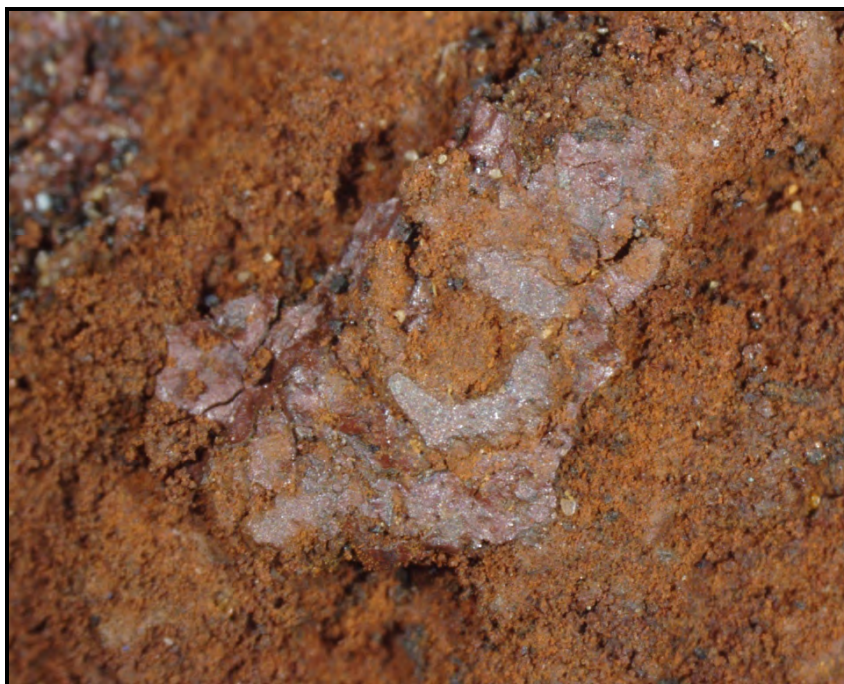
Figure 66: Failed location at 4 o'clock: An overall view of the corroded spot on ID. Note the packed corrosion debris. A higher magnification view of the previous image.

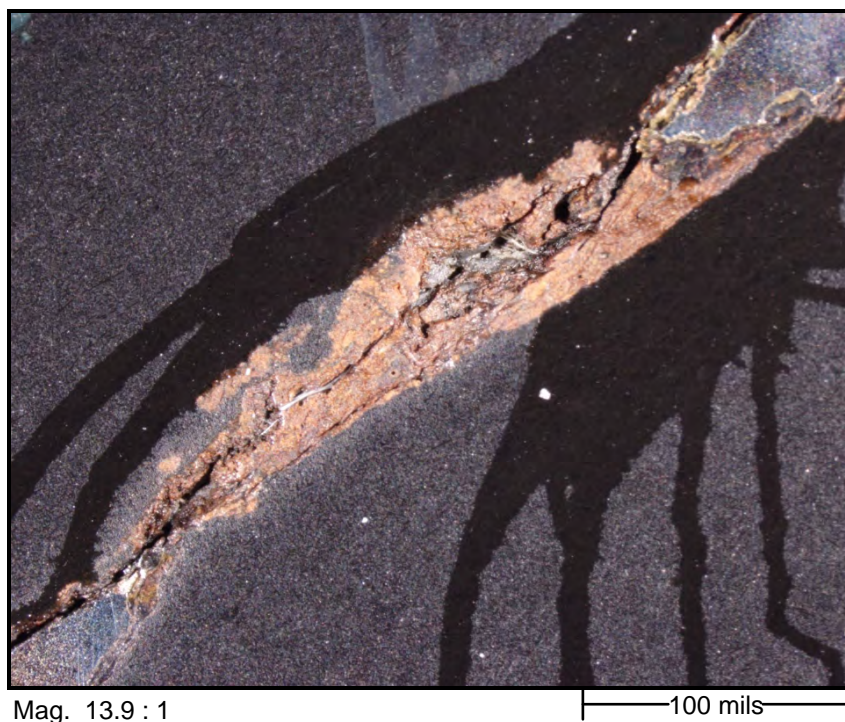
Figure 91: 4 o'clock: An overall view of the mounted cross-section. A higher magnification view of the corrosion debris tightly packed in the pit.

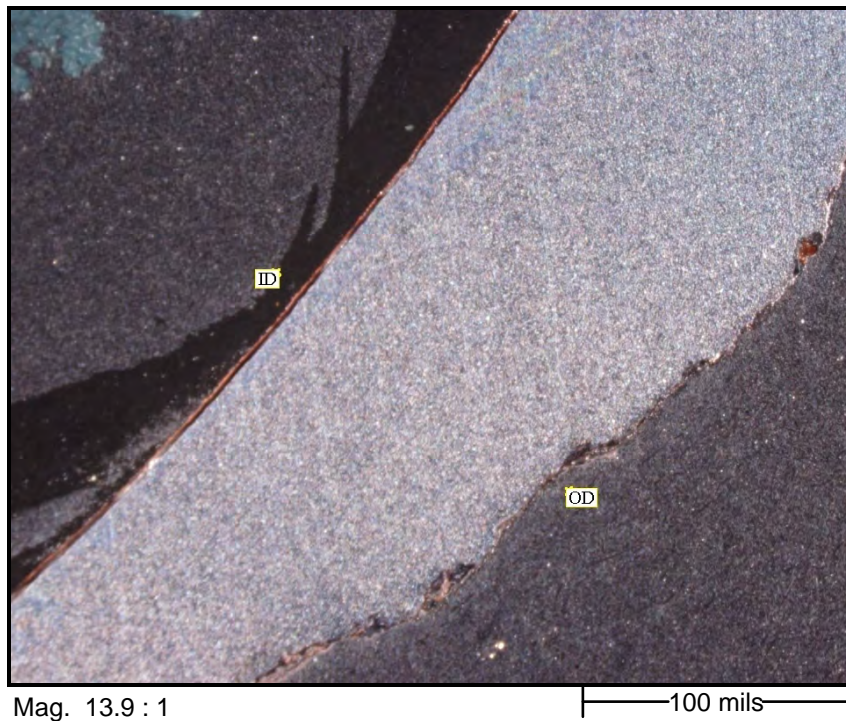
Figure 92: 4 o'clock: An overall view of the mounted cross-section. Note general corrosion on the OD. On the ID a reddish coating layer is present; no corrosion on the ID.

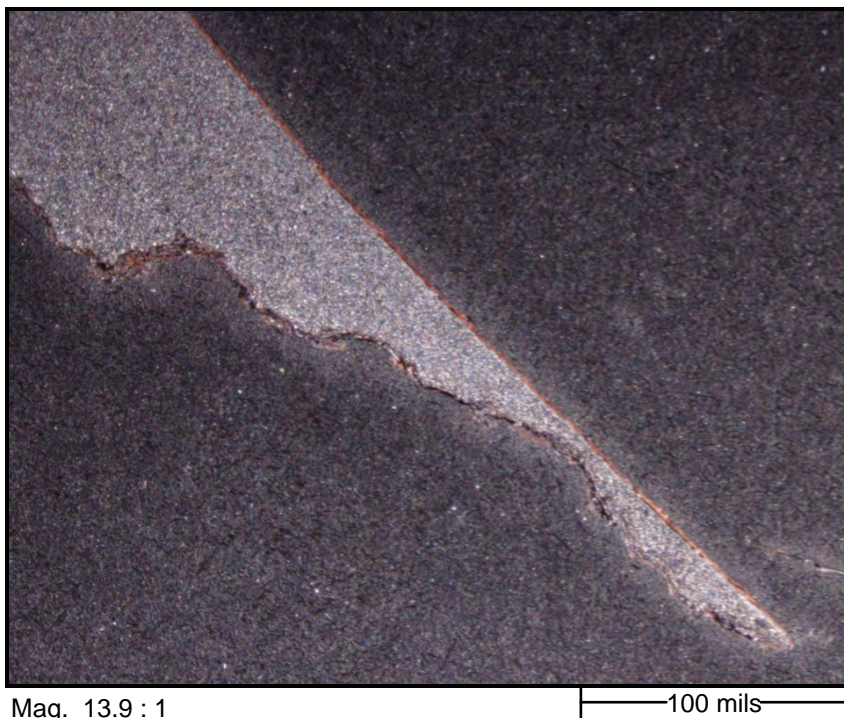
Figure 95: 7 o'clock: An overall view of the mounted cross-section. A higher magnification view of the pit edge. Note the general wall thinning due to corrosion on the tube from the OD and reduction of the wall to knife edge.

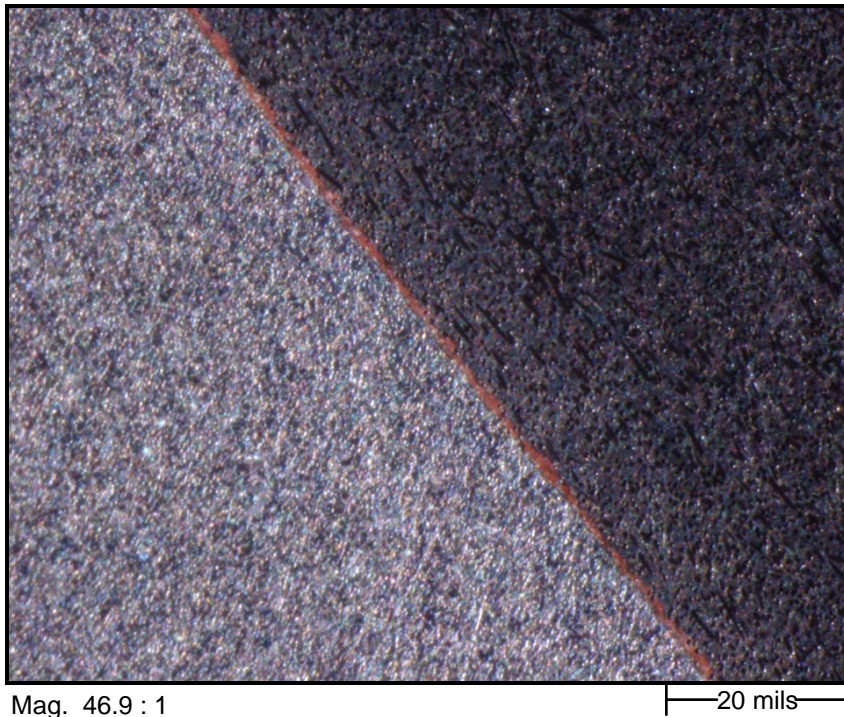
Figure 96: 7 o'clock: Note the reddish paint layer on the ID and no corrosion.

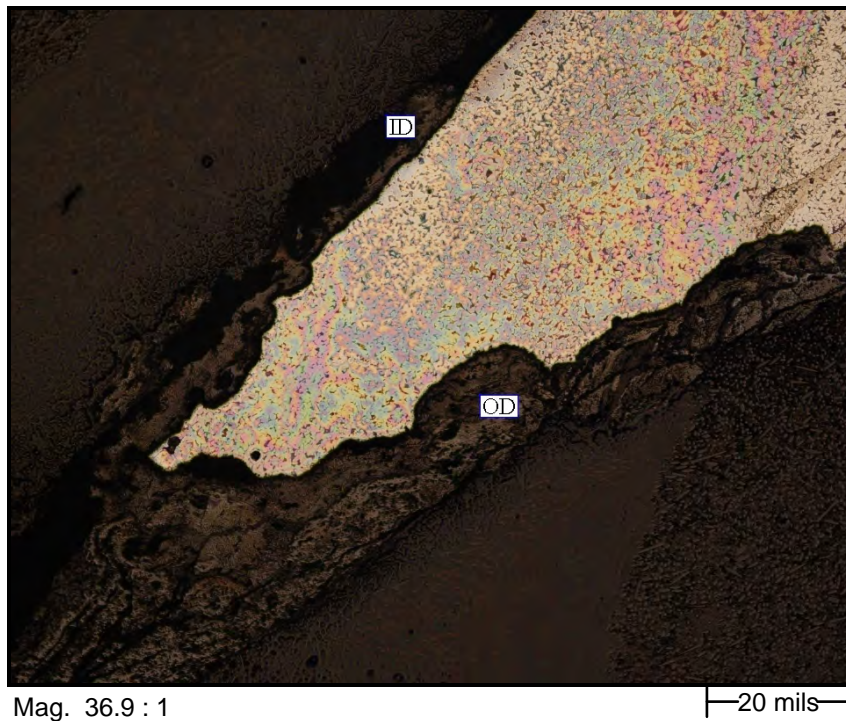
Figure 97: Mount at 4 o'clock: the view shows an edge of the through wall corrosion pit.

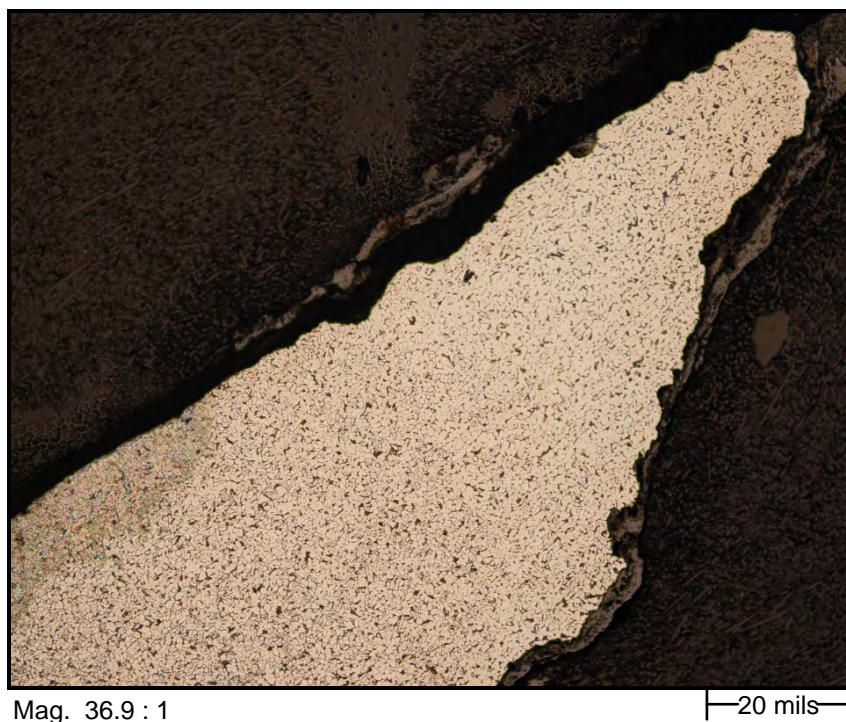
Figure 98: Mount at 4 o'clock: the view shows the opposite edge of the through wall corrosion pit.

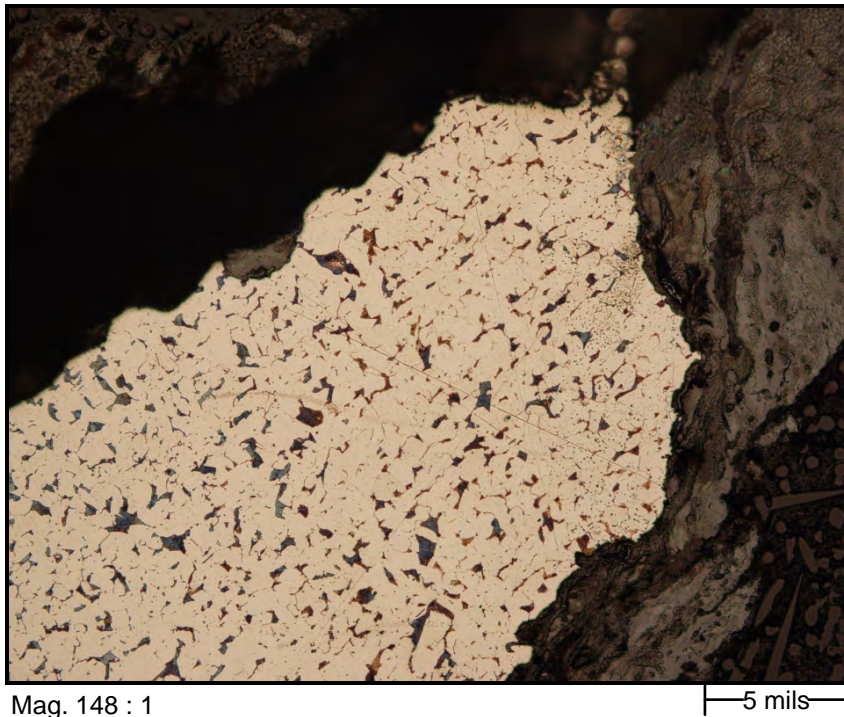
Figure 99: Mount at 4 o'clock: the view shows the opposite edge of the through wall corrosion pit. A higher magnification view of the previous image showing the microstructure.

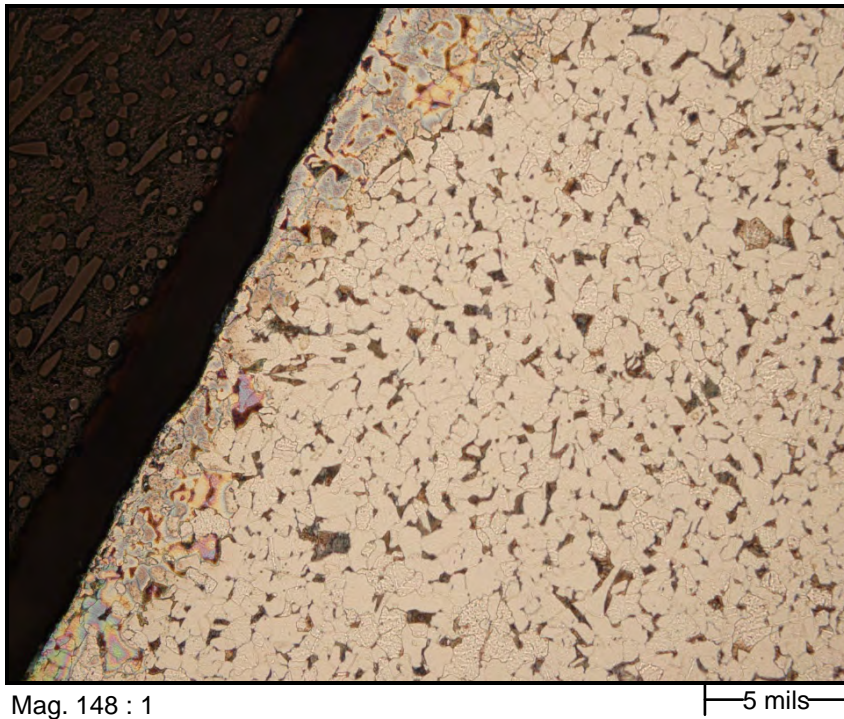
Figure 101: Mount at 4 o'clock: The ID of the tube shows no corrosion.

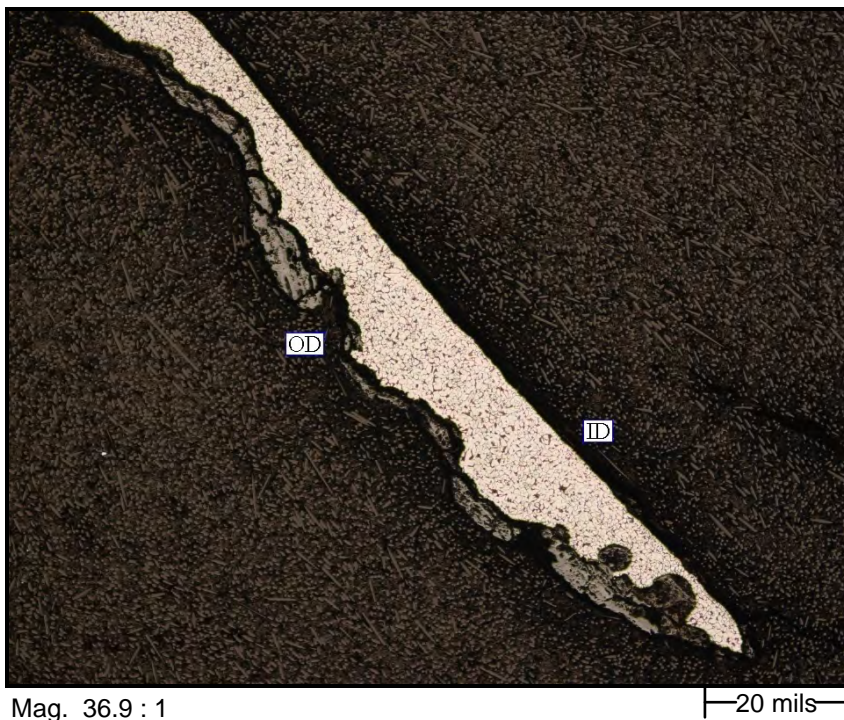
Figure 102: Mount at 7 o'clock: the view shows an edge of the through wall corrosion pit.

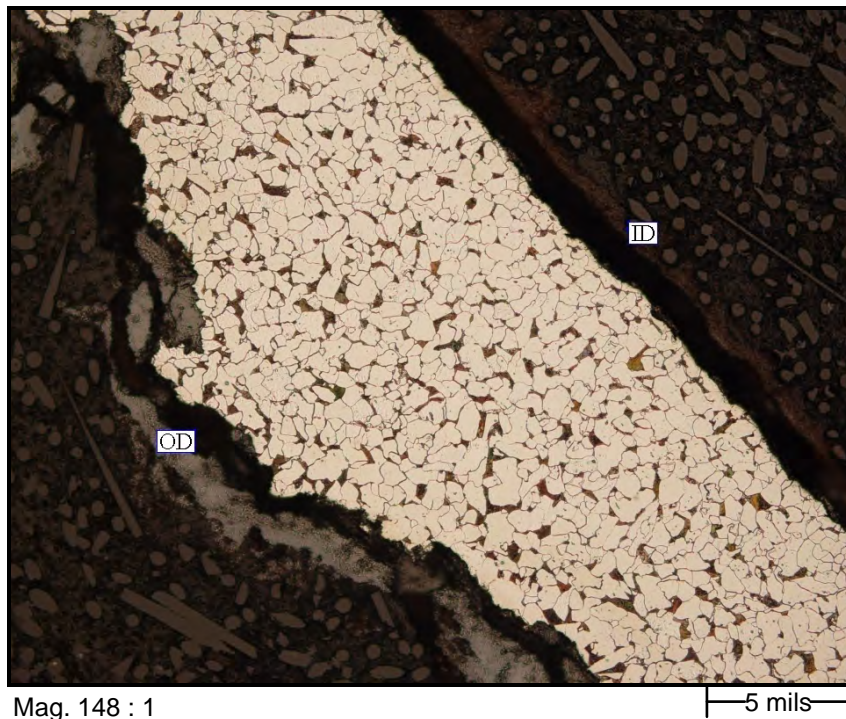
Figure 103: Mount at 7 o'clock: the view shows general corrosion attack on the OD. No corrosion noted on the ID.

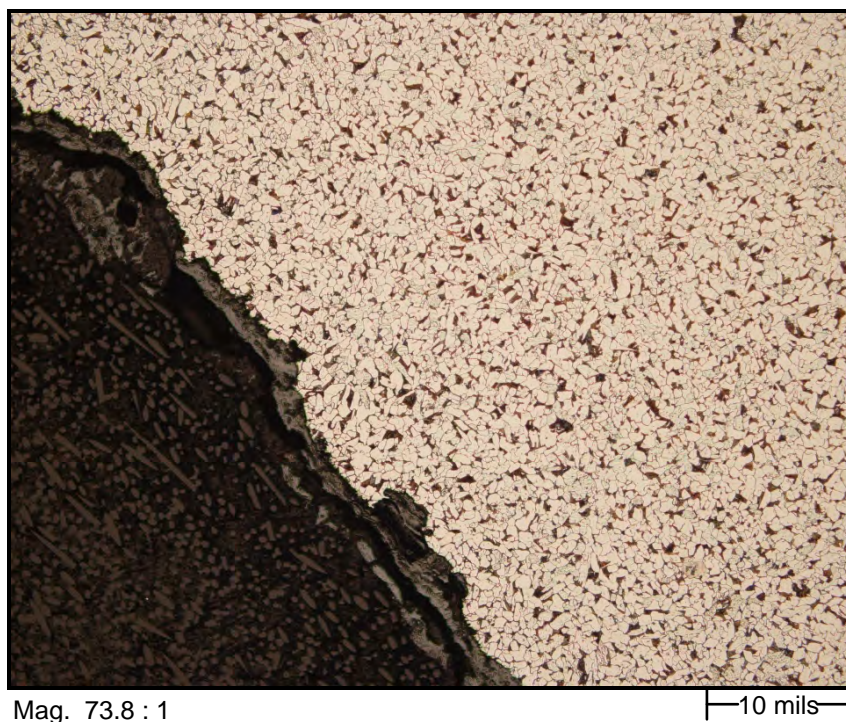
Figure 104: Mount at 7 o'clock: the view shows general corrosion attack on the OD.
