**CAROL A. SHARRIGAN, AS PERSONAL
REPRESENTATIVE OF THE ESTATE OF
GREG J. SHARRIGAN,**
Plaintiff,

**EVERSOURCE ENERGY, and NSTAR
GAS COMPANY d/b/a EVERSOURCE
ENERGY,**

COMPLAINT AND JURY DEMAND

7. At approximately 4:14 p.m. on Thursday, September 2, 2021, a natural gas explosion destroyed a single-family home at 27 Park Street in Maynard, Middlesex County, Commonwealth of Massachusetts. The force of the blast sent the home's windows into the street, caused a significant structure fire, and killed Greg Sharrigan.

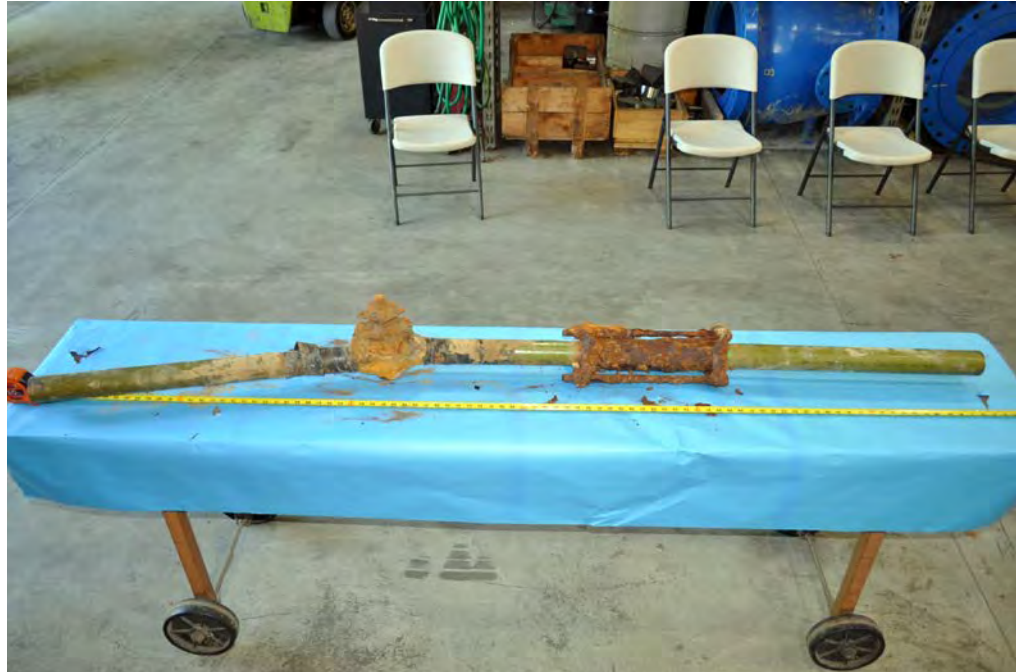
Figure 1:

An overall view of the subject gas main segment with the valve and coupling is shown in Figure 1. Close-up views starting from right-hand side traveling towards the left are in Figures 2-10. The coupling appeared to be in a severely corroded condition. The valve was covered with dirt and rust and the actual condition could not be determined from the overall views. There was black tape noted on the pipe outer diameter (OD) in the areas adjacent to the valve and this is a standard practice. The overall OD of the pipe segments displayed a greenish colored

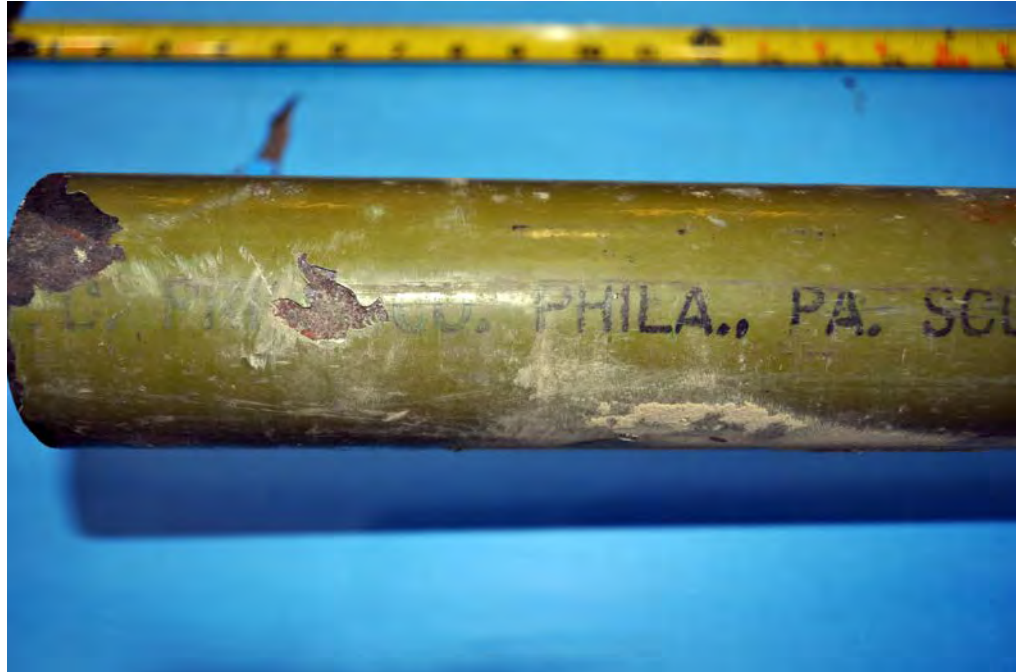
Figure 11:

paint/coating. There was presence of soil on the pipe OD surface in some areas, however, no significant rusting or any other anomalies were observed. Some markings were noted on the pipe pieces which are displayed in Figures 11-15. In some locations the OD coating appeared to be disturbed, Figure 11, which was likely during the handling of the segment. No identification markings were identifiable on the coupling or on the valve.

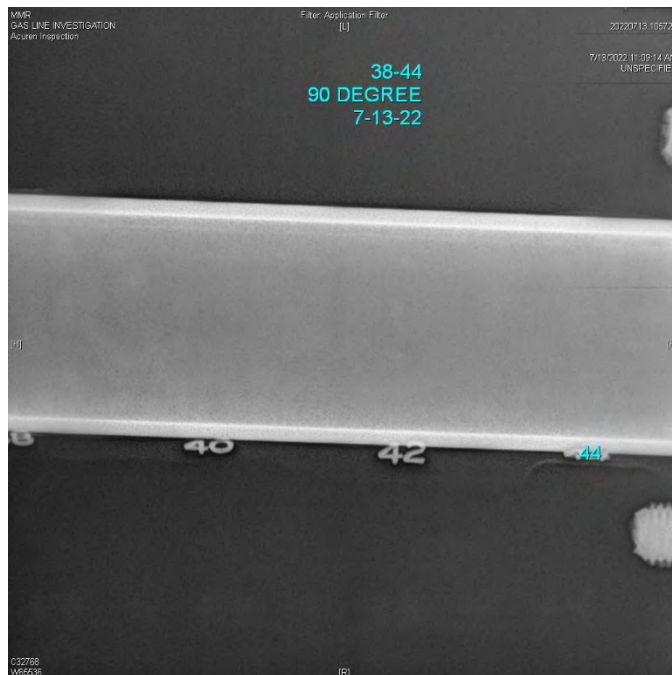
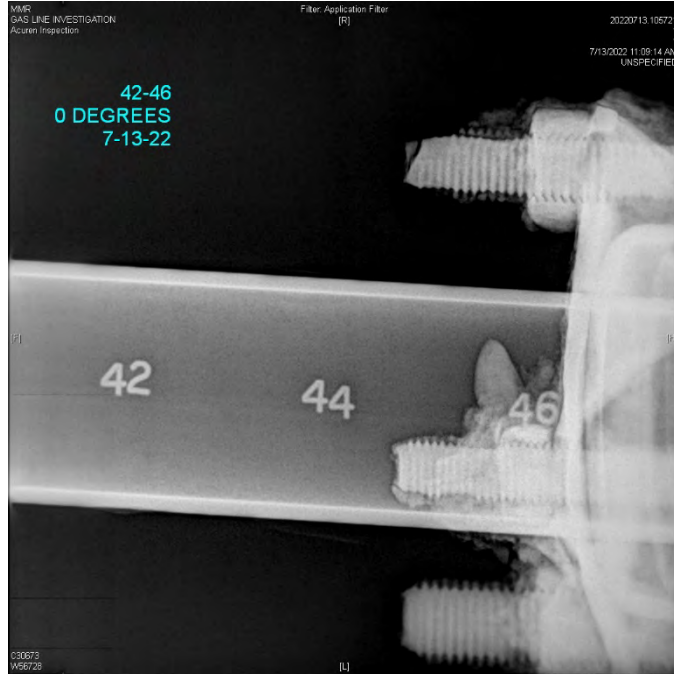
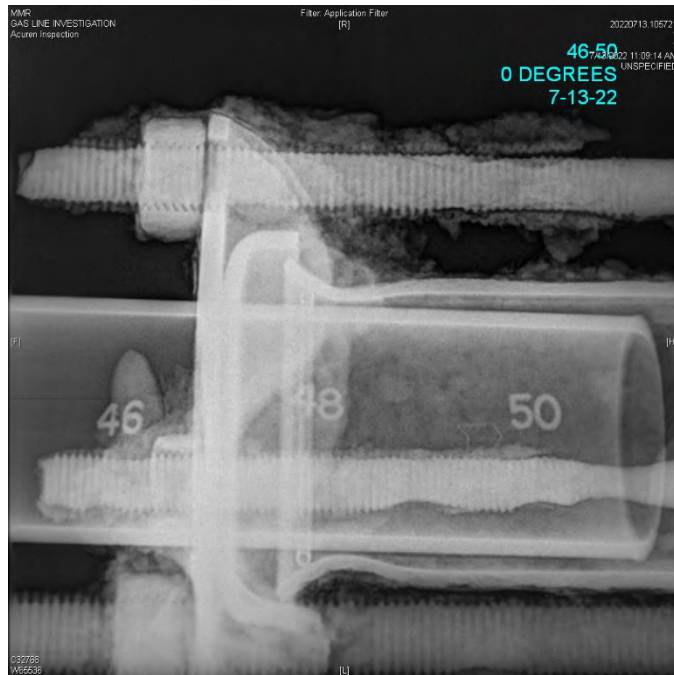
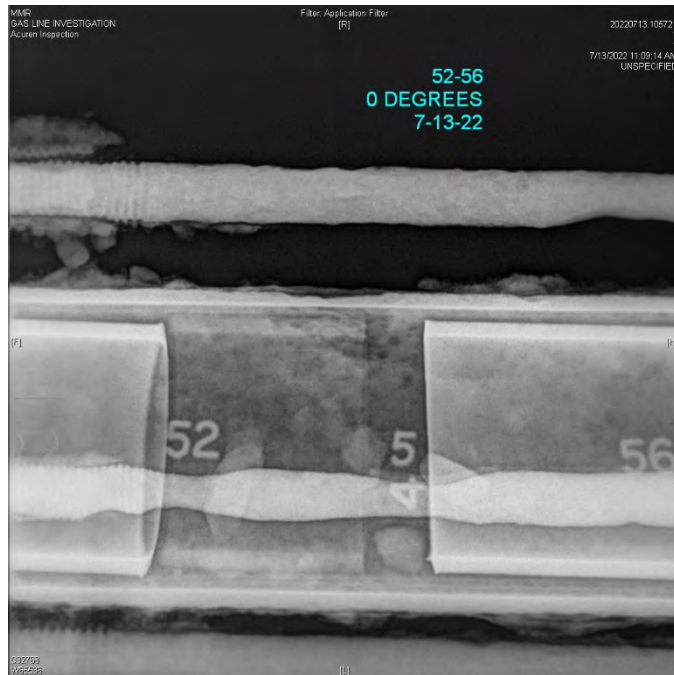
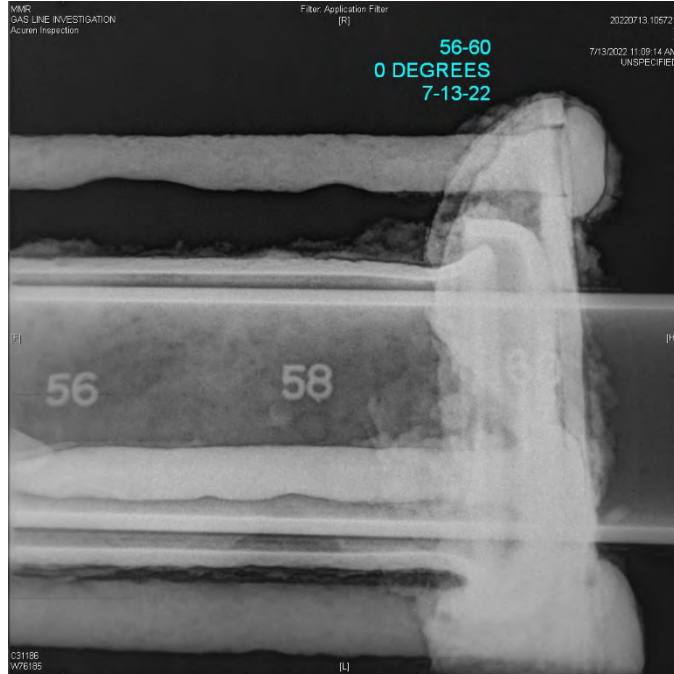
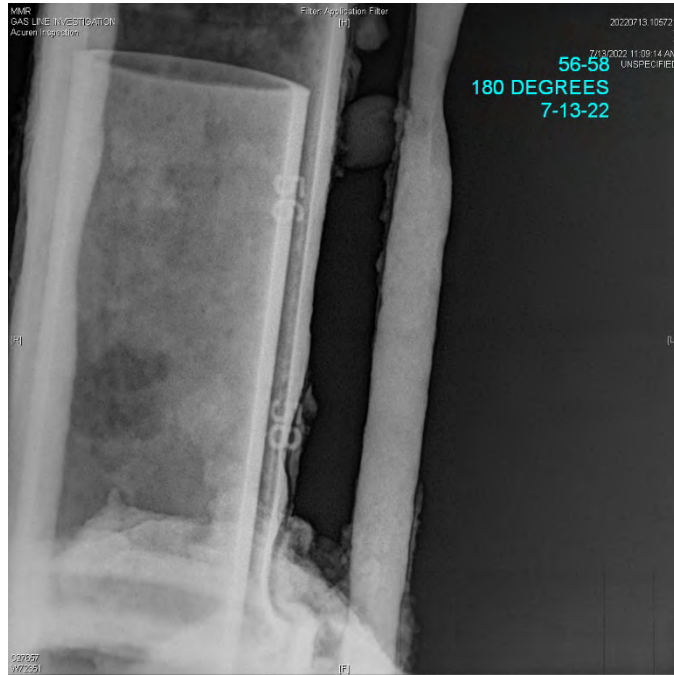
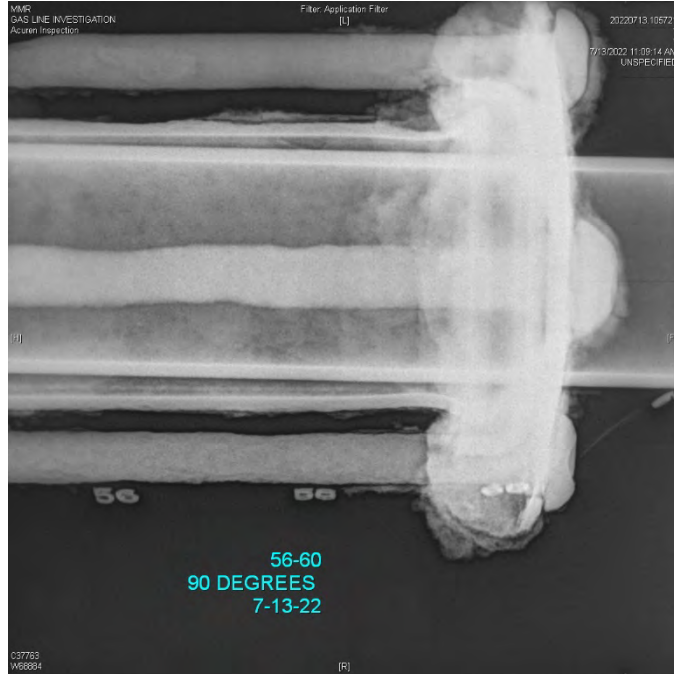
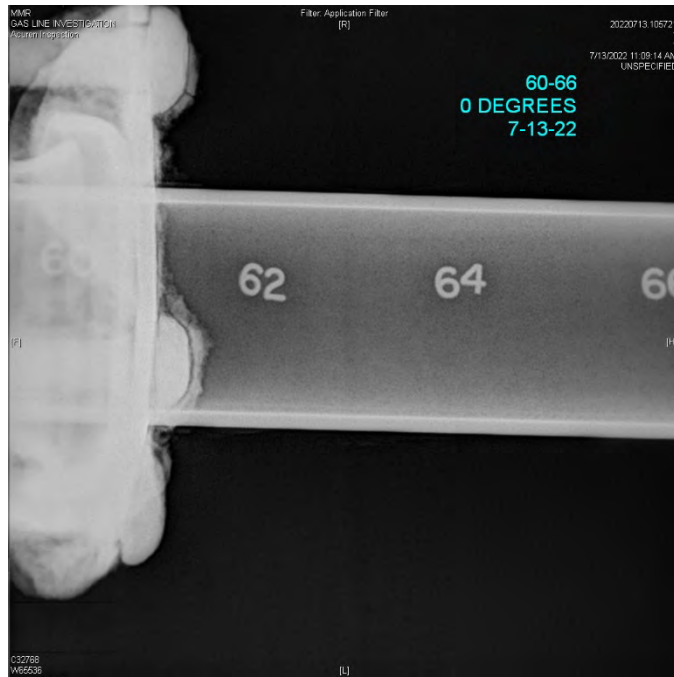
Distances were measured starting at zero on the right hand side in Figure 1. The 12 o'clock position (top of the valve in assembly) was identified as 90° and 3 o'clock position at 0°. Radiographs were taken both at 0° and 90° orientations as needed. The gas main did not show any wall thinning or any other discontinuities/anomalies along the entire length. The valve and valve/pipe joint areas did not show any anomalies also. The coupling tube and bolts displayed significant wall thinning due to corrosion. The wall thinning for the coupling tube was from OD surface. Wall thinning was present at ~58" marking slightly inboard of the coupling edge on the bolt/nut side. The wall thinning area appeared to be isolated to this location and was in-line with the ~7 o'clock position. Representative views from the DR are presented in Figures 16a-16i. Figure 16d shows the gap between the two coupled pipes.

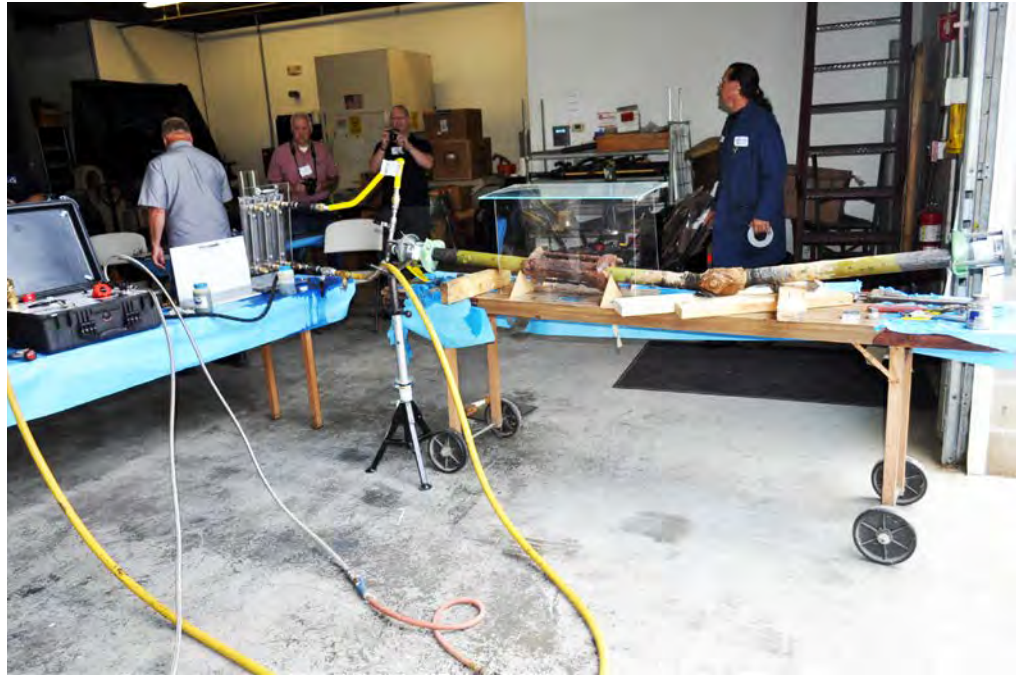
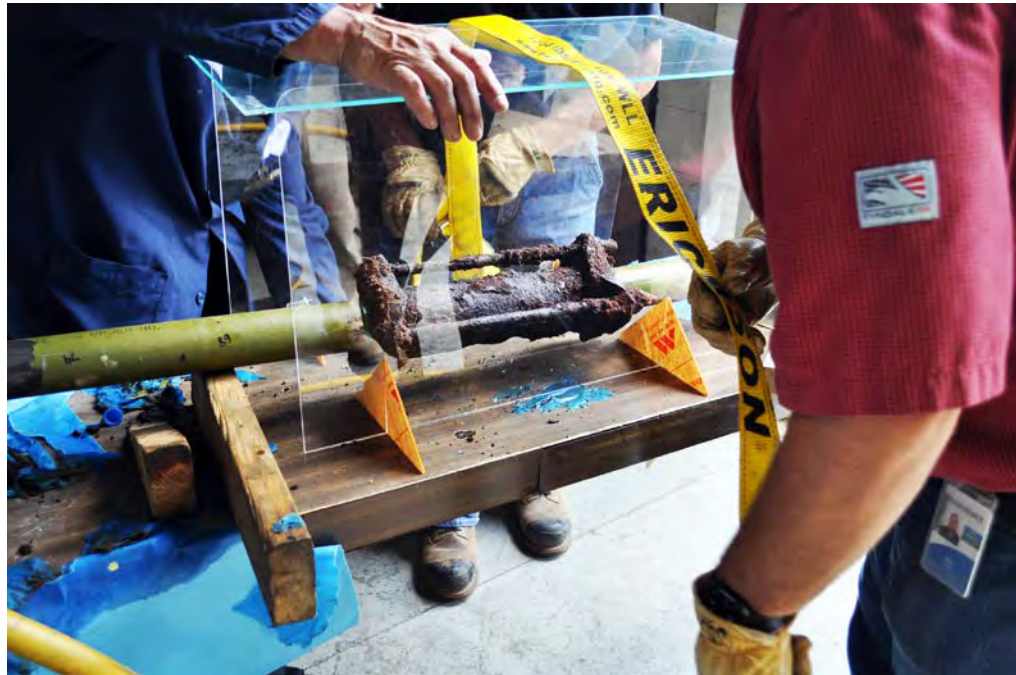
An overall view of the subject pipe segment for the pressure test setup is in Figure 16. An epoxy glass cover was placed around the coupling to stop any sudden fly-out of any particles during the testing (Figure 17). The valve is shown in Figure 18. Note that the segment was laid down with the 12 o'clock (upright position in assembly) sidewise. The segment was placed in this position for easiest way of laying out the components.

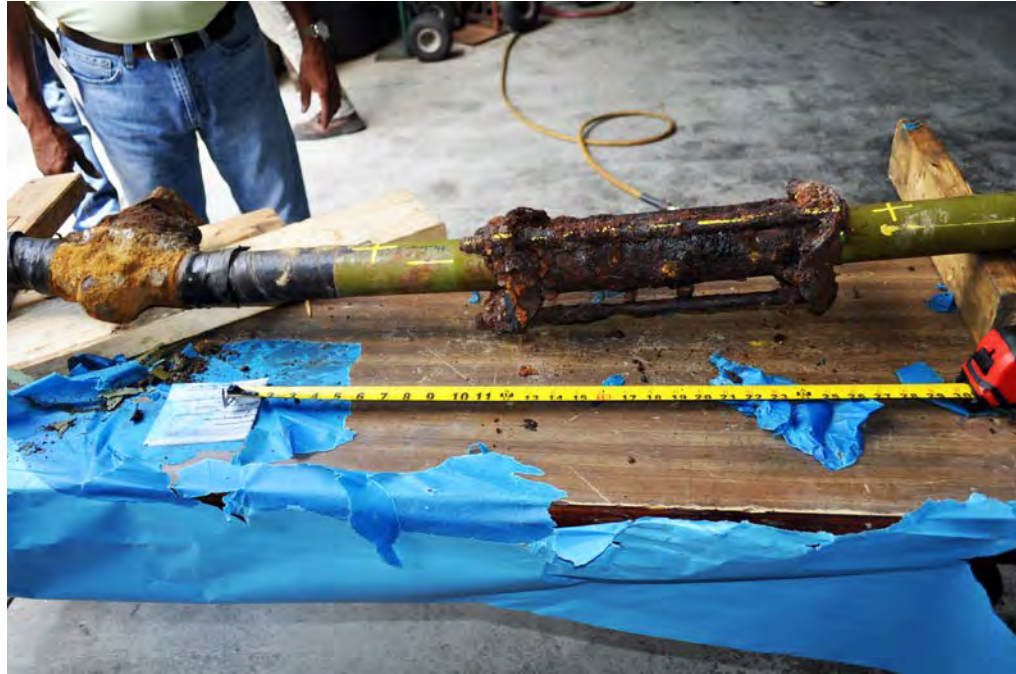
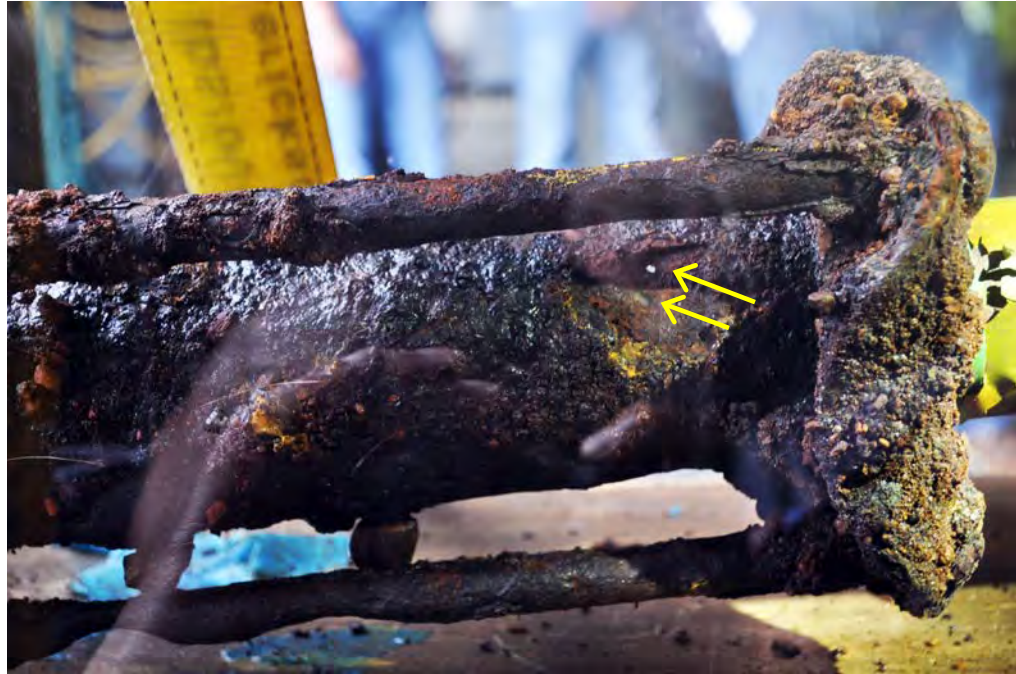
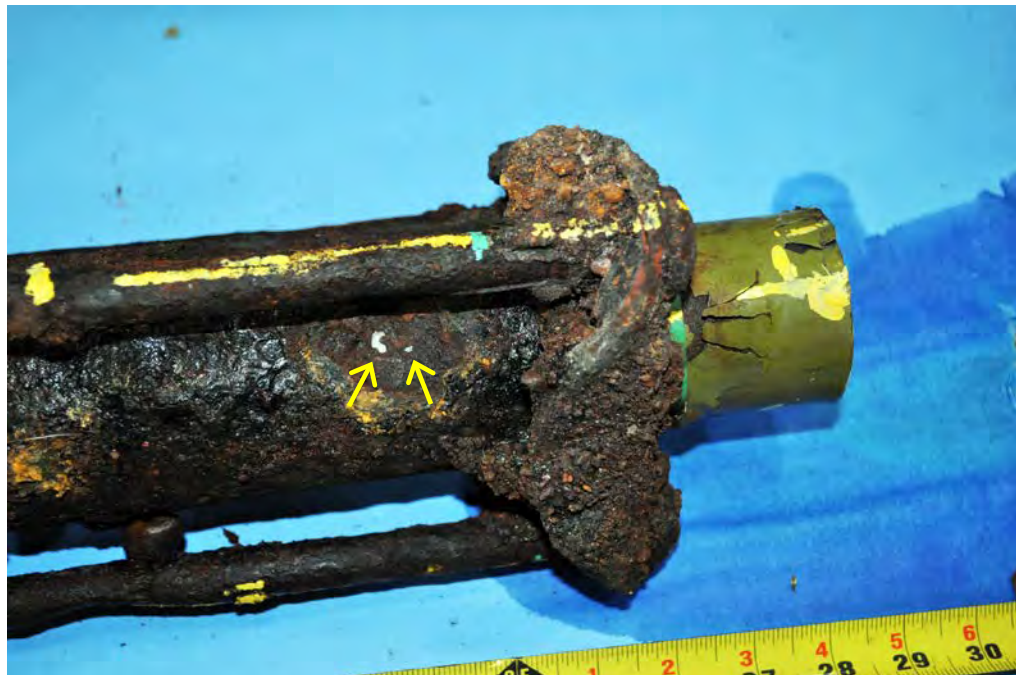
Views of the coupling after the pressure testing are in Figures 22-26. The arrows point to two through hole leaks identified at around 7 o'clock. Note that these through wall leaks were covered with rust or oxidation debris before the pressure testing and were not obvious. During the pressure testing, the oxidation/corrosion debris was forced out and the through wall holes were clearly visible. The long bolts of the coupling were identified as 1, 2 and 3 arbitrarily and the overall views are in Figures 25, 27 and 28. Note that the leaking position at around 4 o'clock was not obvious at this point. Next the long bolts were sectioned off using a bandsaw. The views after removing the bolts are in Figures 29-31. The green lines in Figures 30 and 31 show the cut lines and the witness lines. The segment between the two circumferential parallel green lines would contain the leaking positions. A band saw was used to make the cuts, Figure 32. Views of the segments after the circumferential cuts are in Figures 33-39. From the overall views the gas main pipe inside the coupling appeared to be in good condition without any evidence of

Semiquantitative chemical compositional analysis on the OD surface and near the corrosion pits revealed elevated level of elemental chlorine in the deposit. Note that the element chlorine is aggressive to a steel pipe in moist environments. In some areas of the buried gas mains, water can be collected (water pools) and cause corrosion of the steel couplings. It could not be unequivocally determined whether there was a paint/coating present on the OD surface of the coupling initially due to extensive corrosion and removal of the original wall condition. Even in the presence of a thin paint or coating, with significant length of service time, some breaching of the coating can be typically expected which would initiate the corrosion process.

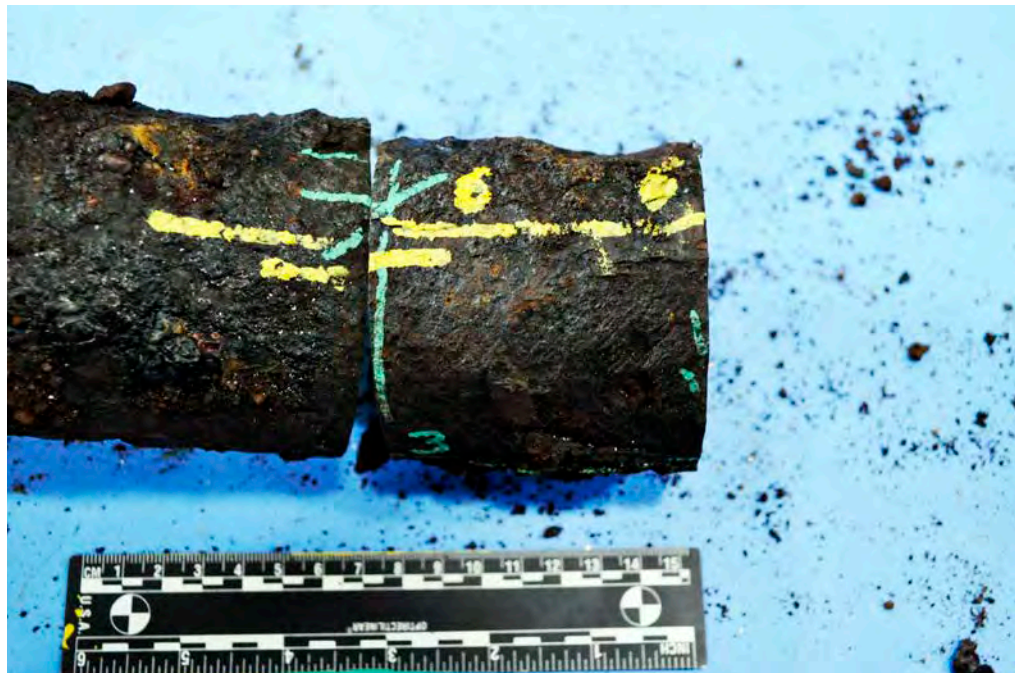
corrosion or wall thinning. The OD wall of the coupling appeared to be significantly corroded; the ID wall appeared to be in good condition. There was a polymer liner on the ID of the coupling and around the OD of the gas main. The three removed bolt sections are in Figure 36. Figure 40 shows a schematic of the cuts on the excised segment with the leaks. The smaller segment containing the leaks were identified with clock positions, Figures 37-39. This shows a lengthwise cut to be made along 3 and 9 o'clock line and followed with the cut in the lengthwise direction at 6 o'clock. This would separate the 7 o'clock and 4 o'clock leaking locations. The gas main segment at the leaking location inside the coupling is in Figure 41. The polymeric liner at the ID of the coupling is in Figure 42. All of them appeared to be in good condition. There was some evidence of rust colored deposit on the polymer lining. The half diameter section containing the 12 o'clock position is displayed in Figures 43-47. The views clearly show significant corrosion of the OD of the coupling, no significant oxidation/corrosion on the ID of the coupling or on the ID/OD of the gas main. The polymer liner appeared to be in good condition. The ID of the coupling displayed a reddish colored paint/coating. The OD of the gas main displayed a greenish colored paint/coating.

Figure 36: Excised bolts from the coupling.

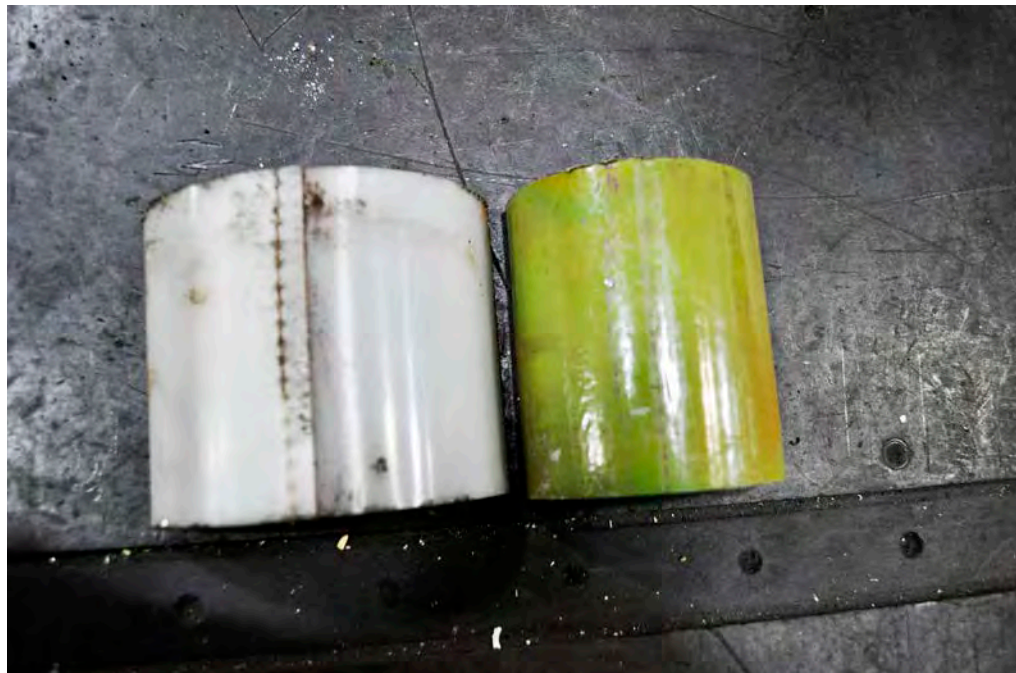
Figure 48:

Views of the segment containing the leak are in Figures 48-57. This segment contained the welded seam on the polymeric coupling, Figures 48 and 49. The weld seam location was at around 5-6 o'clock location in assembly. These views show a deep corrosion pit at around 4 o'clock location which revealed slight leaking during the pressure testing. OD views of 4 o'clock and 7 o'clock locations are in Figures 51 and 52, respectively. The ID view of these two locations are in Figure 53. Through wall holes are observed at 7 o'clock. The 4 o'clock location displayed a large rust type debris on the ID. Overall view of the segment containing the leaks are in Figure 54 showing the ID of the coupling, polymeric liner and the gas main. The OD view of these segments are in Figure 55.

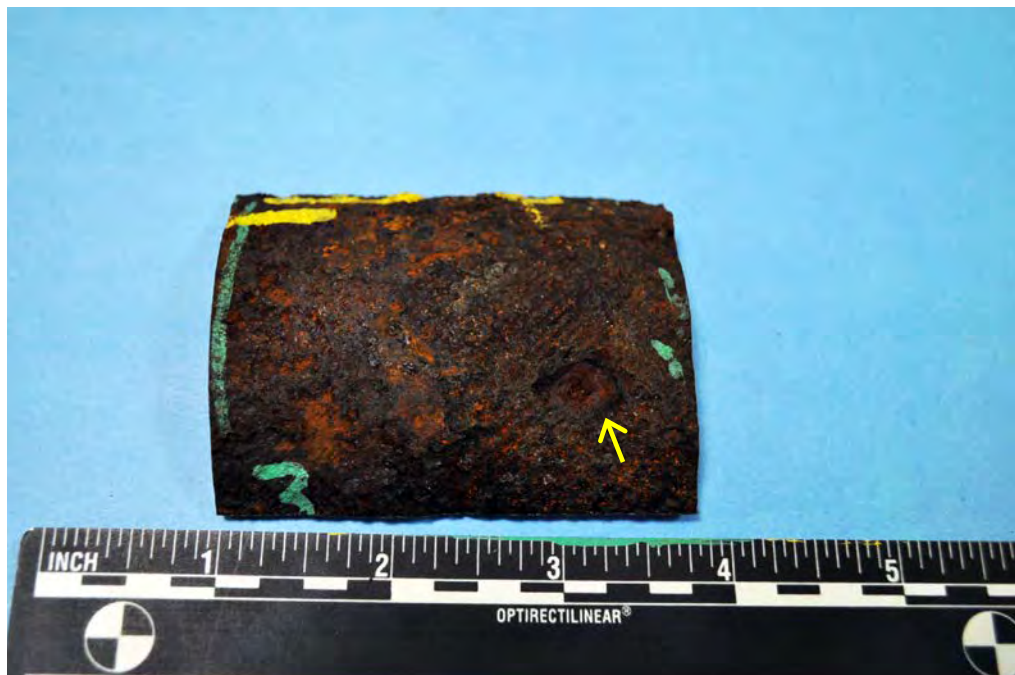
Figure 50: Arrows point to 7 o'clock leak (top) and a possible leak @ 4 o'clock (bottom).

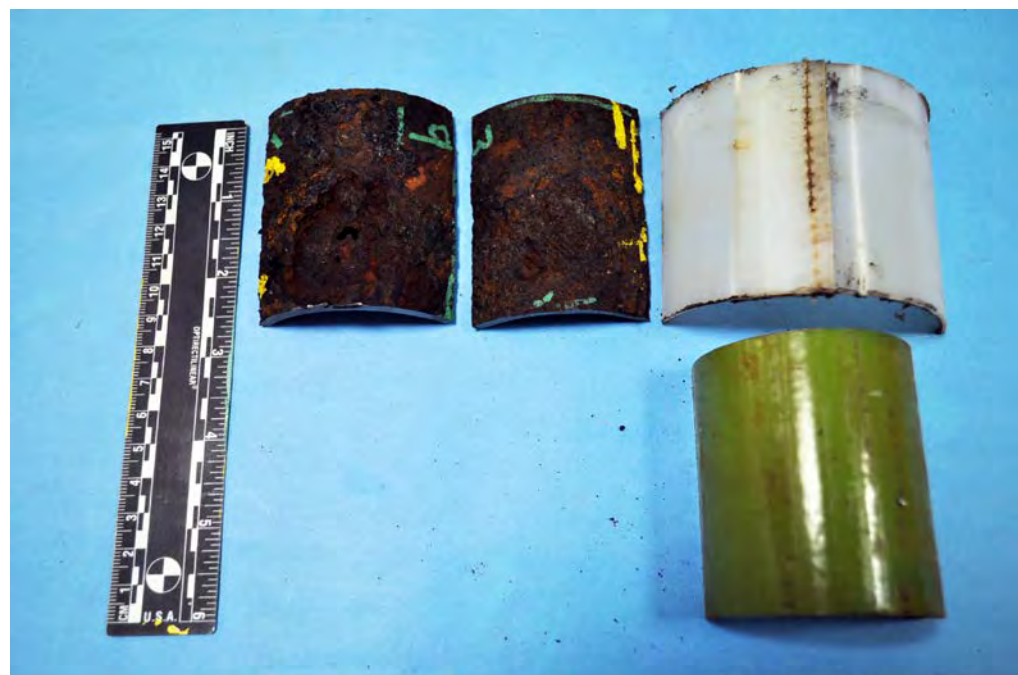
Figure 54: ID view of the components in the leaking segment.

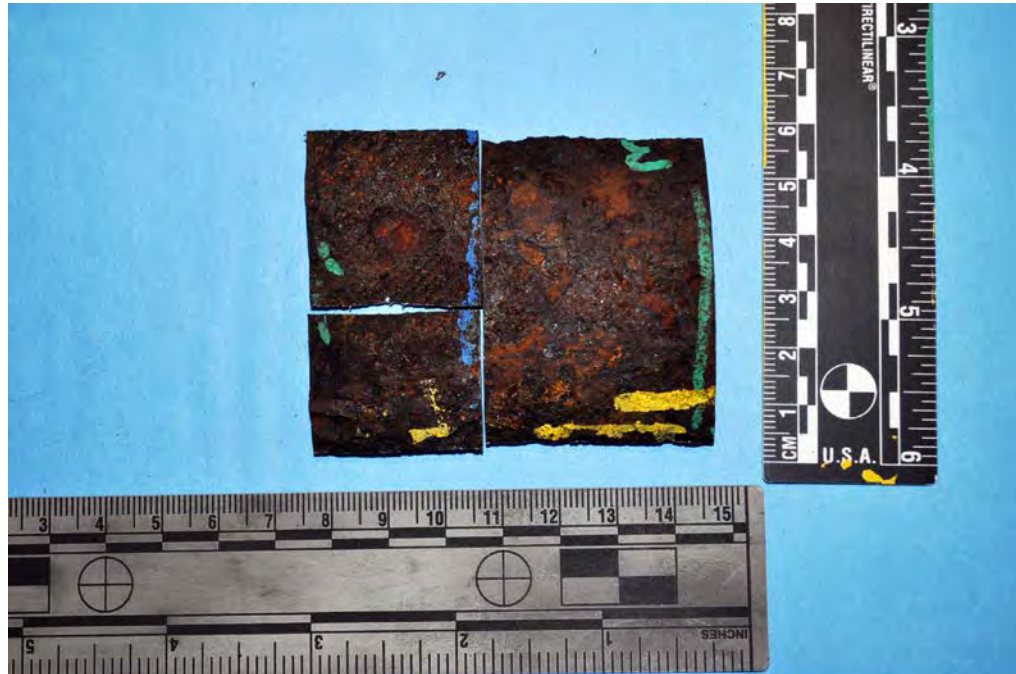
Figure 55: OD view.

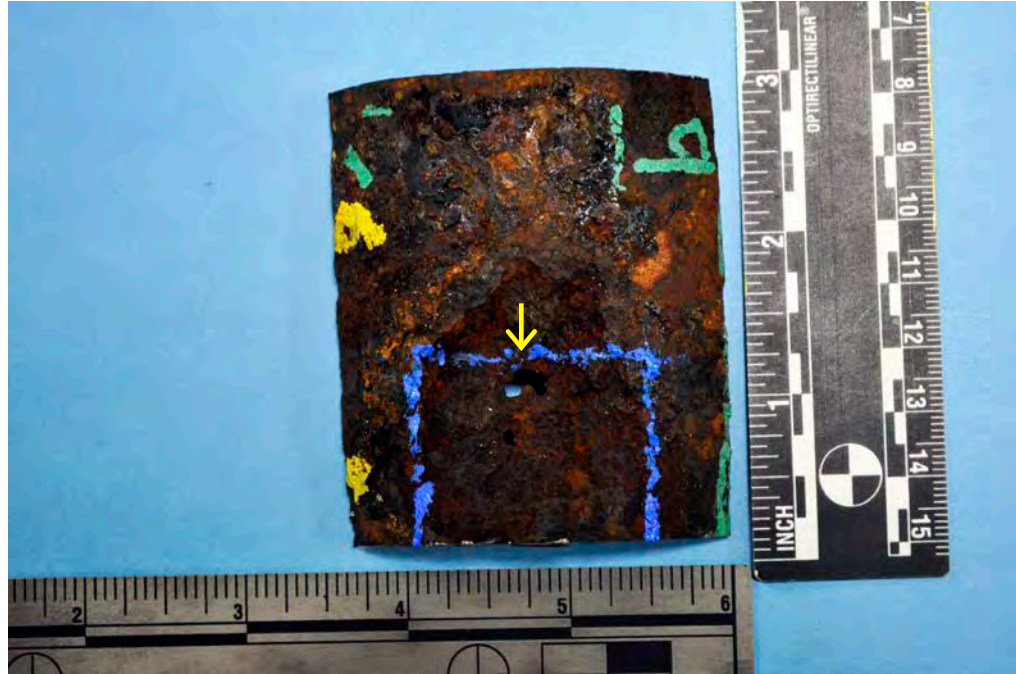
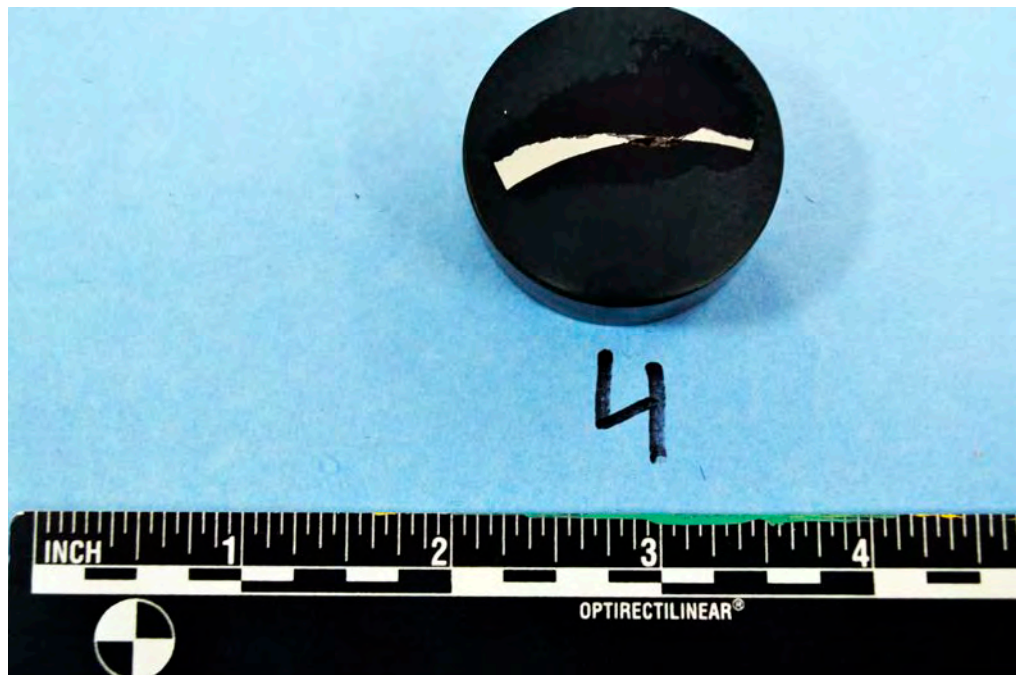
Next, additional cuts were made closer to the leaking areas for mounting purposes. Arrows in Figures 57 and 58 show the mounted plane for 4 o'clock and 7 o'clock leaking locations.

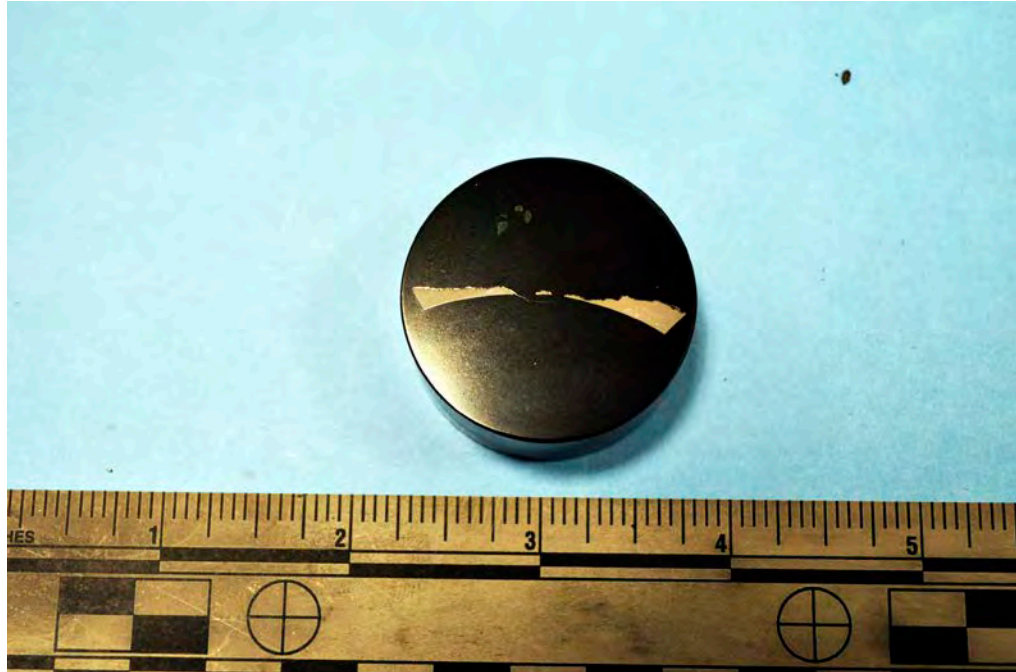
Overall view of the mount at 4 o'clock is in Figure 59 and that at 7 o'clock is in Figure 60. Two through wall holes are obvious in the 7 o'clock location. The mount at 4 o'clock shows presence of oxide scale at the through hole location with small areas of leaking passage. The views clearly showed that there was significant corrosion from the OD surface of the coupling and the wall thickness was reduced to knife edges at the leaking locations. Other areas of the coupling also displayed significant corrosion.

Figure 59: Mounted cross-section at 4 o'clock.

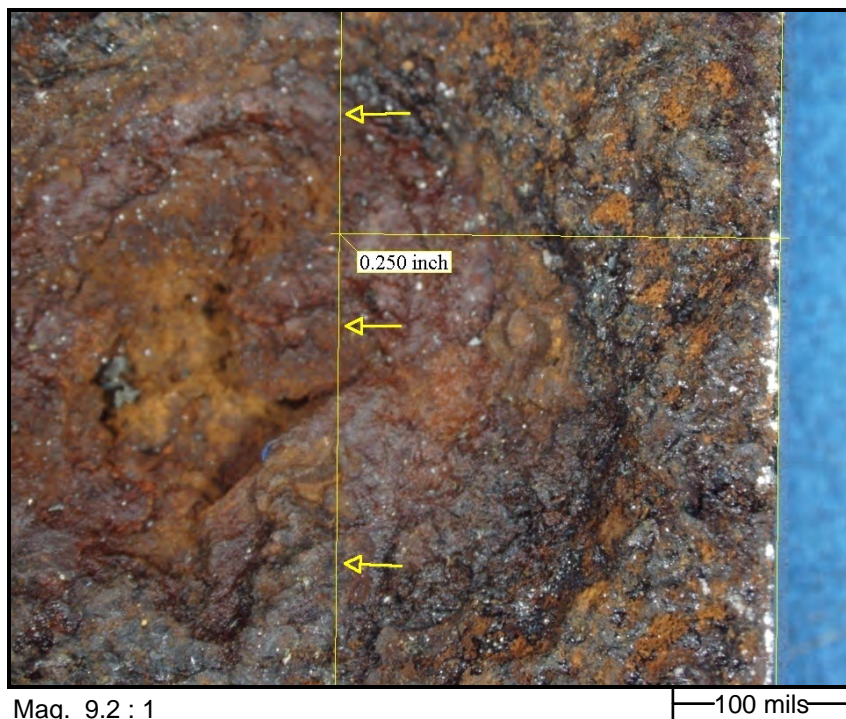
Stereomicroscope examination was performed on the excised smaller segments with leaking areas. For the leaking location at 4 o'clock, visually a through wall penetration was not obvious. However, stereomicroscope examination showed that there were small areas of through wall leak path among the tightly packed corrosion debris. An overall view of this location is displayed in Figure 61 with a higher magnification in Figure 62. The OD surface adjacent to this location displayed some parallel markings only present adjacent to this location. An overall view of this area in Figure 56 shows these markings; the markings are almost at a 45° angle to the lengthwise direction of the coupling. Overall views of these markings are obvious in Figures 63 and 64.

Figure 66: Failed location at 4 o'clock: An overall view of the corroded spot on ID. Note the packed corrosion debris. A higher magnification view of the previous image.

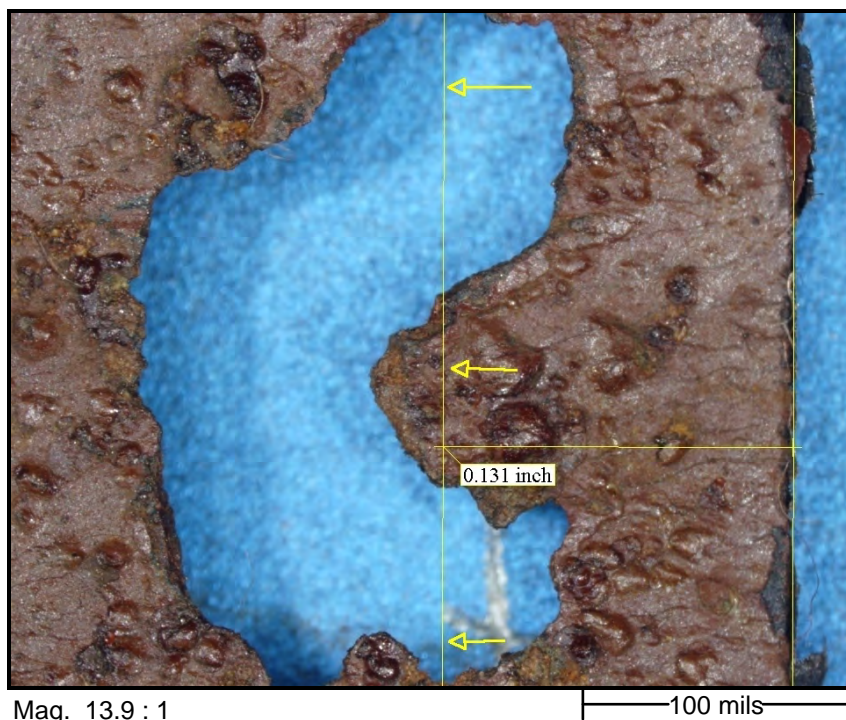
Note that this area on the OD of the coupling has been significantly corroded reducing the overall wall thickness. Presence of these markings may indicate that the surface was in contact with a surface from which impression was created on this location. Even with wall thickness loss, the impression was still there indicating that the surface was in close contact with this mating external surface. The views from the ID surface at this location are in Figures 65 and 66; the views clearly show the tightly packed corrosion debris in the area. Figure 67 shows the cut line and the mounted plane through this location.

Figure 67: 4 o'clock anomaly: Arrows point to the mounted plane.

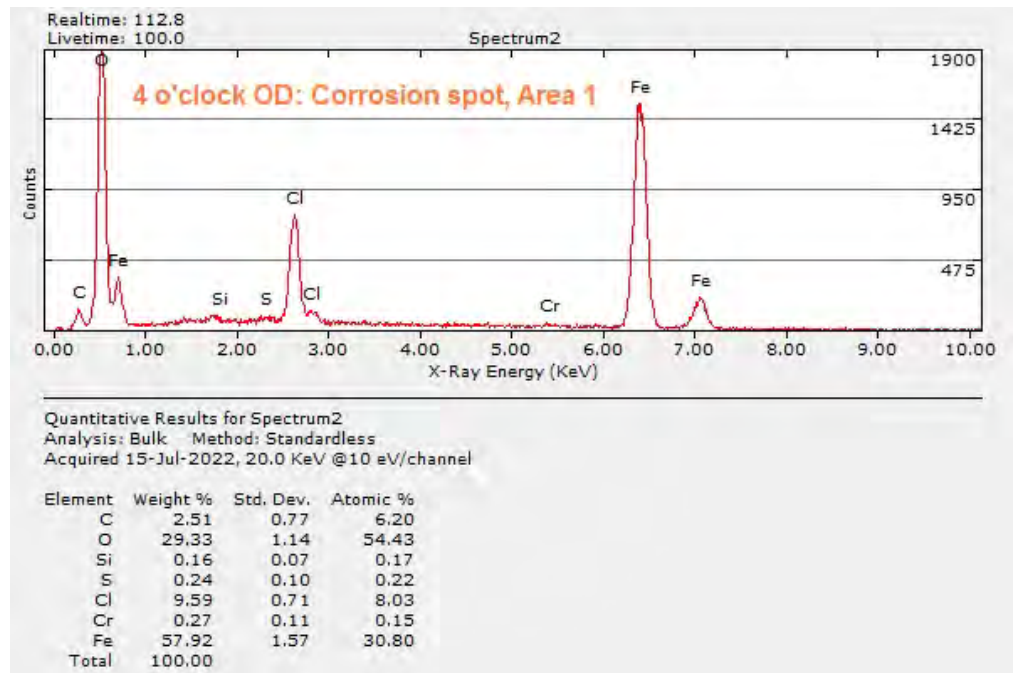
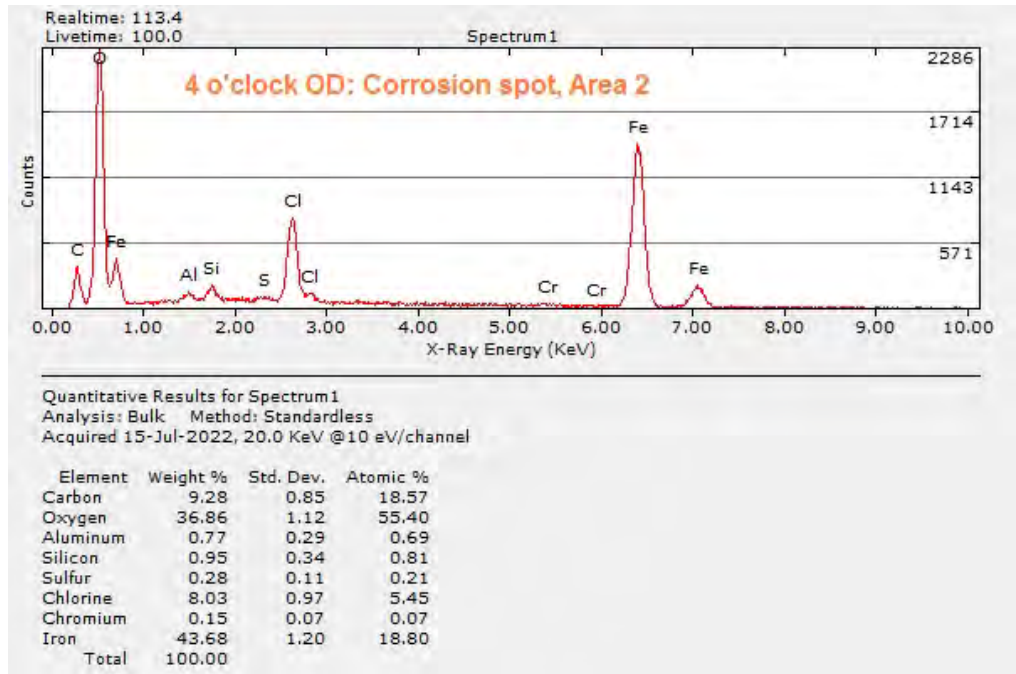
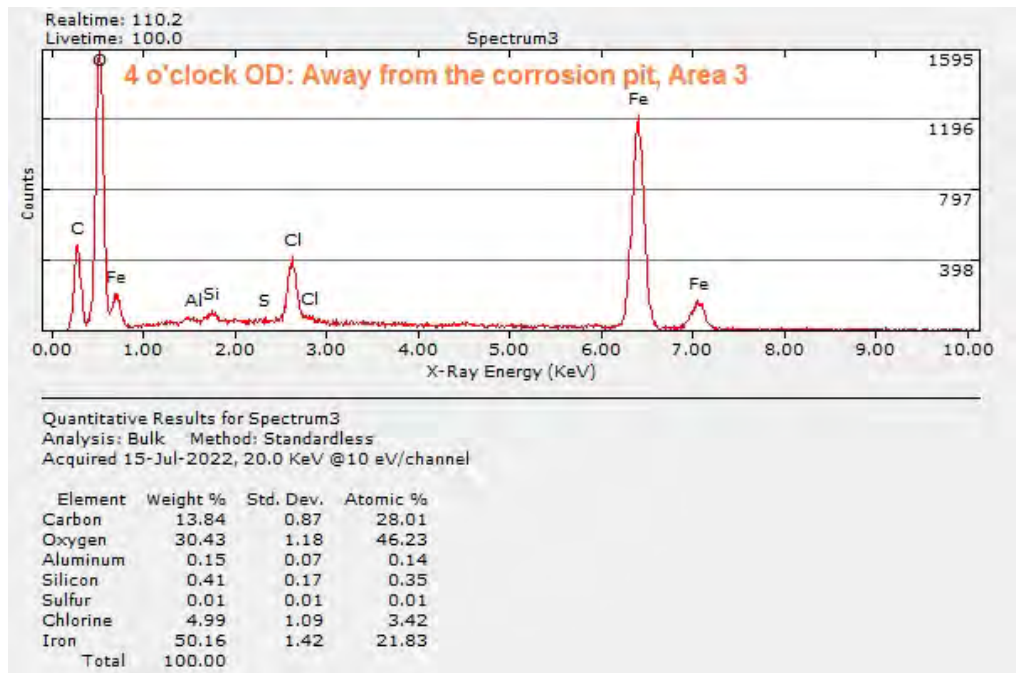
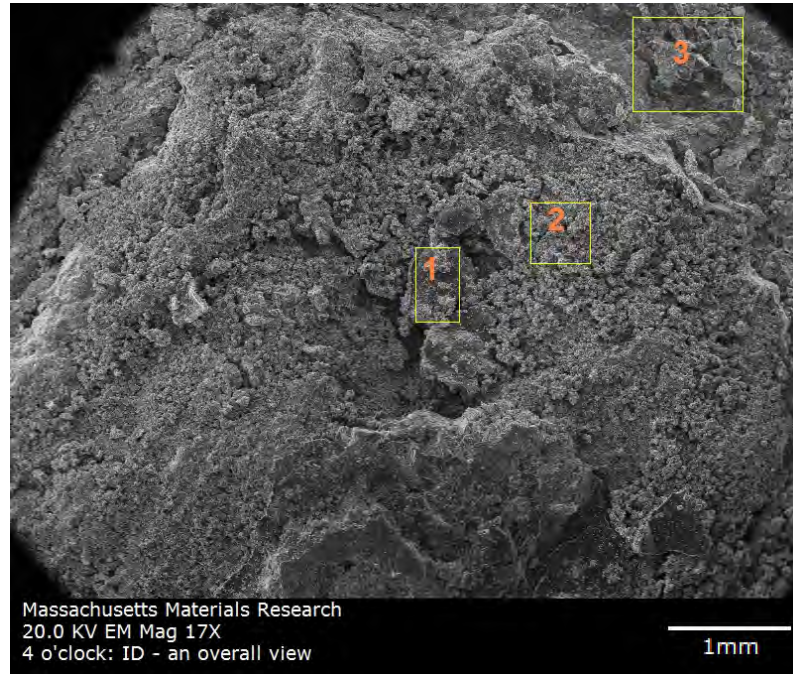
4 o'clock Pit: An overall view of this pitted area is in Figure 69. The areas identified in rectangular boxes were analyzed by EDS and the spectrograms are in Figures 70 and 71 from the areas. One location away from the corrosion pit was also analyzed, Area 3 (not in the view), and the spectrogram is in Figure 72. Note that the samples were not cleaned before the EDS analysis. In all the areas similar elements were identified which are: major amounts of oxygen (O, ~30 wt.%) and iron (Fe, ~50 wt.%); minor amounts of carbon (C, ~10% wt.%) and chlorine (CL, ~8 wt.%); trace amounts of silicon (Si), sulfur (S), aluminum (Al) and chromium (Cr). The levels of trace elements are <1wt.%. The elevated level of oxygen indicates that there is iron oxide on the surface and inside the pit created during oxidation/corrosion of the iron base material. The level of chlorine is higher (~10 wt.%) inside the pit compared to the away location (~5 wt.%). This would indicate that chlorine is the aggressive element on the OD surface which is causing the corrosion of the steel coupling material. The source of carbon is likely an organic coating which was present (probably) on the OD surface of the coupling tube. Note that on the ID surface there is a reddish coating/paint present on the coupling. However, on the OD surface there is no evidence of any paint as the original surface is corroded away. If there was no coating present on the original coupling tube surface, then carbon is indicative of the soil/dirt present as organic contamination. Elements sulfur, silicon and chromium can be present in trace amounts in the material itself; the elevated levels of these elements can also come from the soil surrounding the coupling tube.

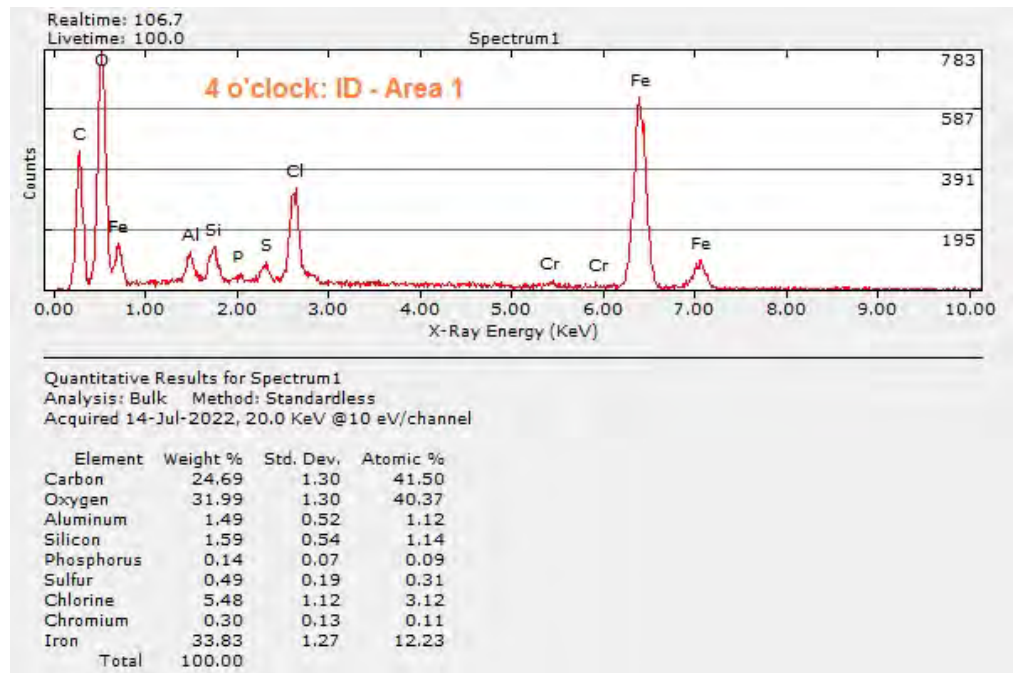
Figure 73:

An overall view of the corroded area on the ID is displayed in Figure 73. The areas identified were analyzed by EDS and the spectrograms are presented in Figures 74-76. The areas again displayed elevated level of oxygen indicative of iron oxides. The level of carbon is elevated on the ID surface compared to the OD. This likely confirms that the carbon is from the coating which was found to be present on the ID in most of the locations. In some areas levels of aluminum and silicon are elevated which may be from the coating or from the soil/dirt on the OD surface. There was consistent presence of elemental chlorine on all the areas identified. Note that the chlorine is from the OD surface environment which penetrated through the through wall hole locations to the inside surface of the tube.
