**CAROL A. SHARRIGAN, AS PERSONAL
REPRESENTATIVE OF THE ESTATE OF
GREG J. SHARRIGAN,**
Plaintiff,

**EVERSOURCE ENERGY, and NSTAR
GAS COMPANY d/b/a EVERSOURCE
ENERGY,**

COMPLAINT AND JURY DEMAND

7. At approximately 4:14 p.m. on Thursday, September 2, 2021, a natural gas explosion destroyed a single-family home at 27 Park Street in Maynard, Middlesex County, Commonwealth of Massachusetts. The force of the blast sent the home's windows into the street, caused a significant structure fire, and killed Greg Sharrigan.

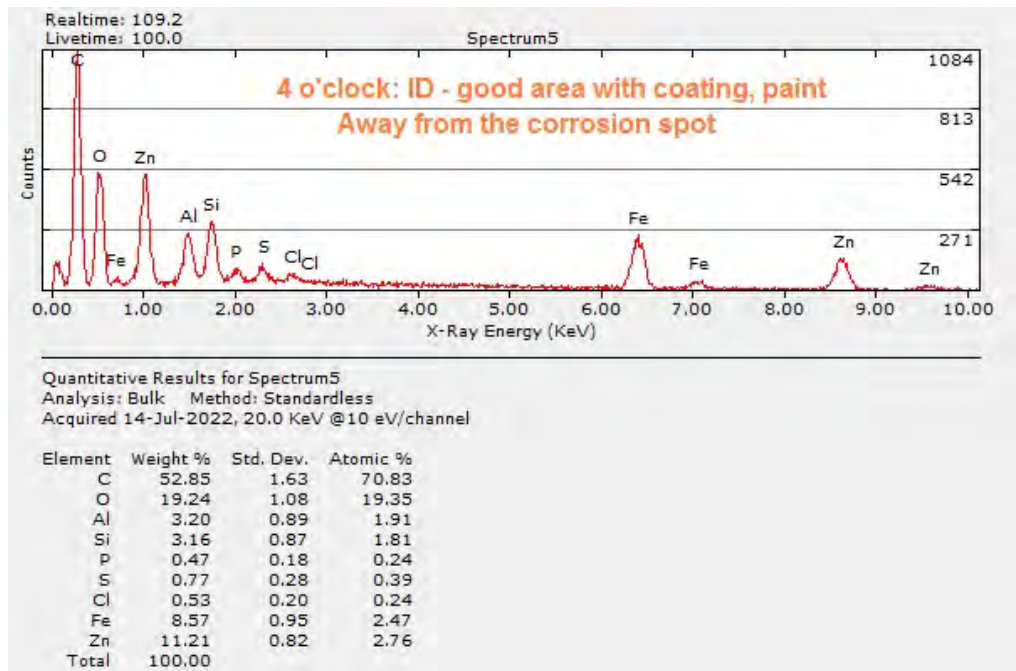
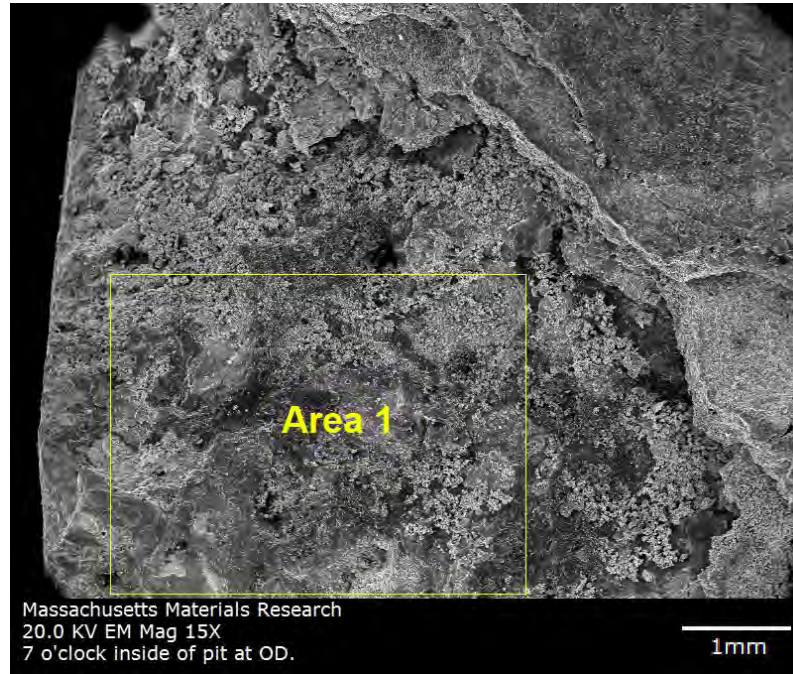
Figure 77:

Figures 77 and 78 show two areas on the ID away from the corrosion pit. In these areas the reddish type paint was intact. The level of carbon is at ~50 wt.% with oxygen at ~20 wt.% in these areas. There are minor amounts of iron (~9 wt.%) and zinc (~11 wt.%) together with trace amounts of aluminum (Al, ~3 wt.); silicon (Si, ~3 wt.); phosphorous (~0.50 wt.%) and sulfur (S, ~0.70 wt.%). These elements indicate that they are indicative of the coating on the ID surface of the coupling. A small amount of elemental chlorine was noted which could be from the outside environment which penetrated through the perforated locations.

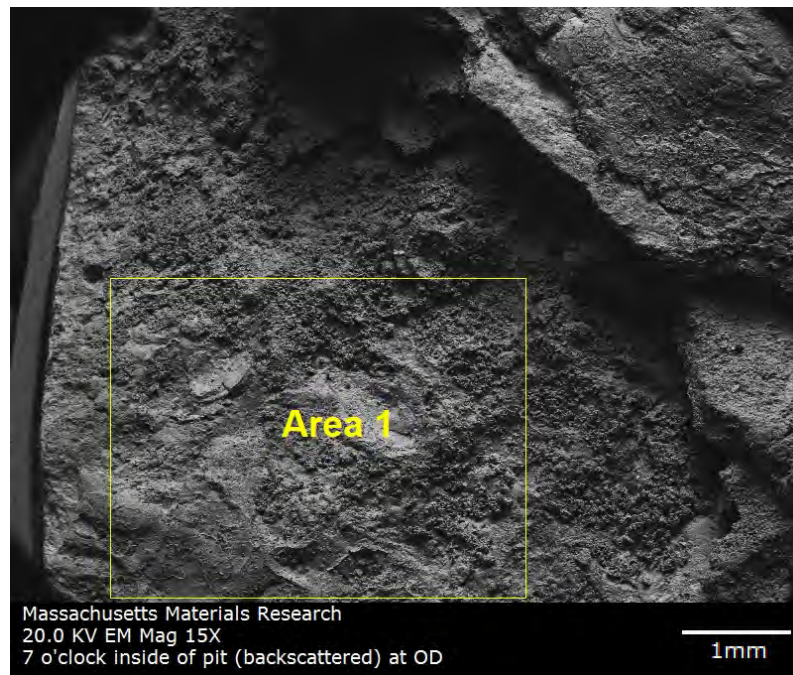
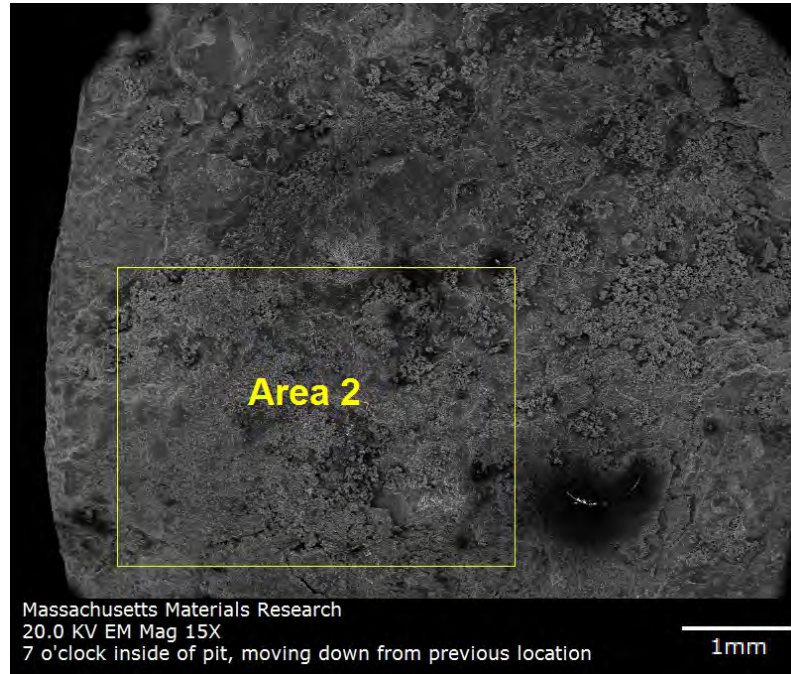
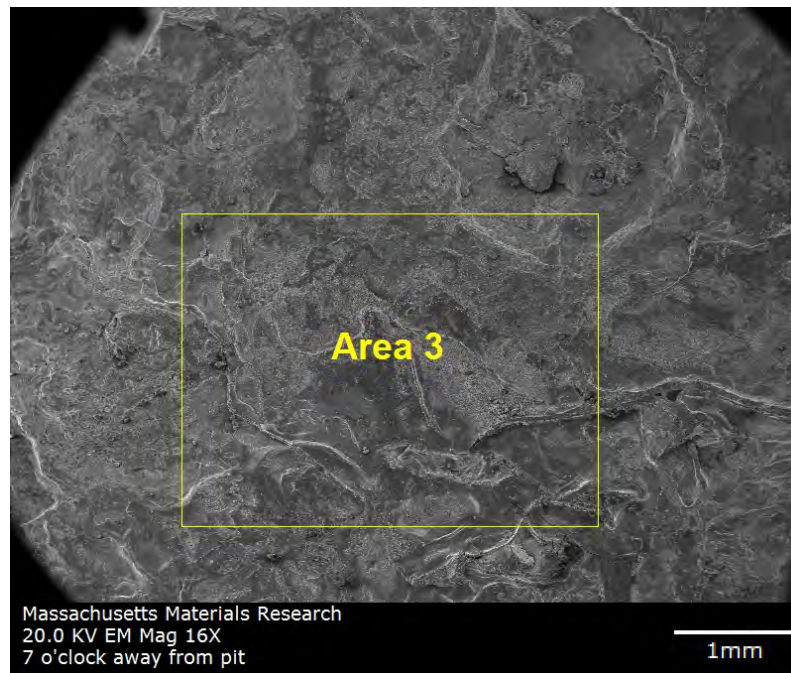
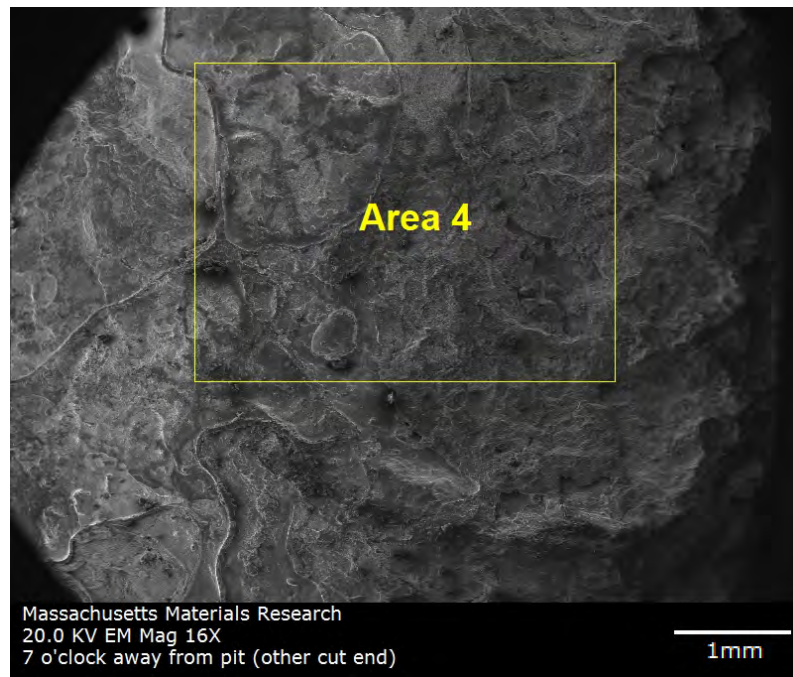
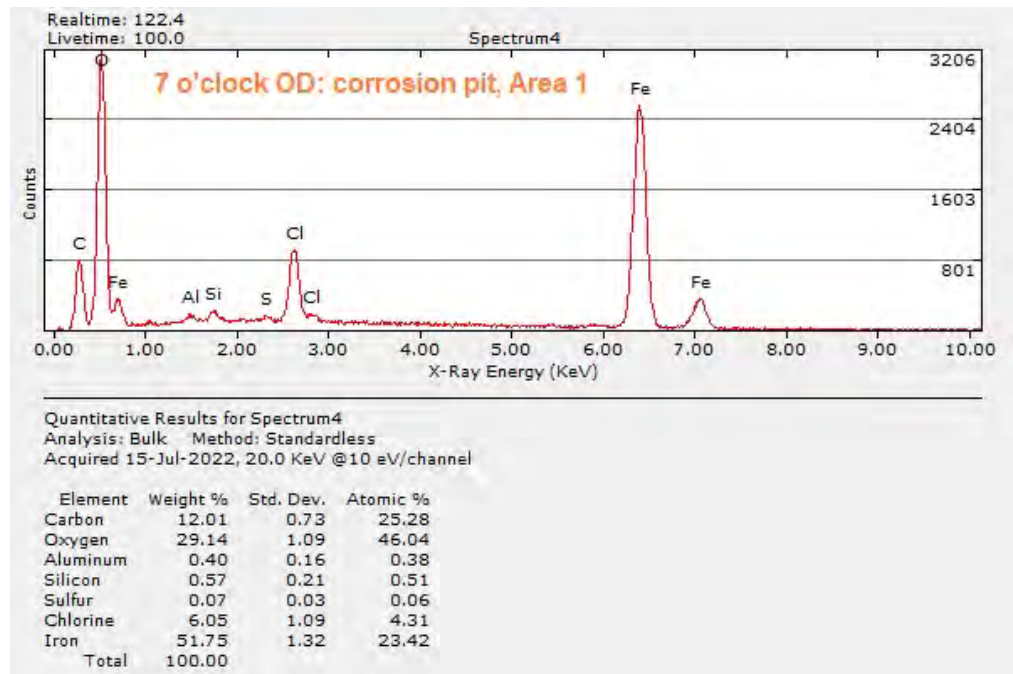
Figure 79:

7 o'clock Anomaly: Note that this area displayed through holes and the OD surface adjacent to the through hole pits were analyzed. The different views are in Figures 79-83 and the areas analyzed are shown in these views. The representative spectrograms from the areas are in Figures 84-87. All the areas analyzed typically show elevated levels of oxygen and iron indicating iron oxide. There was always presence of minor amounts of carbon which may either be from the coating present or from the organic environment the surface is in contact with in service. The results showed consistent presence of elemental chlorine, the source of which is also from the service environment on the OD surface. Only one location, Area 4, in Figure 87 did not show any chlorine and displayed only a predominant amount of iron with a minor amount of oxygen. This shows oxidation of the steel tube material.

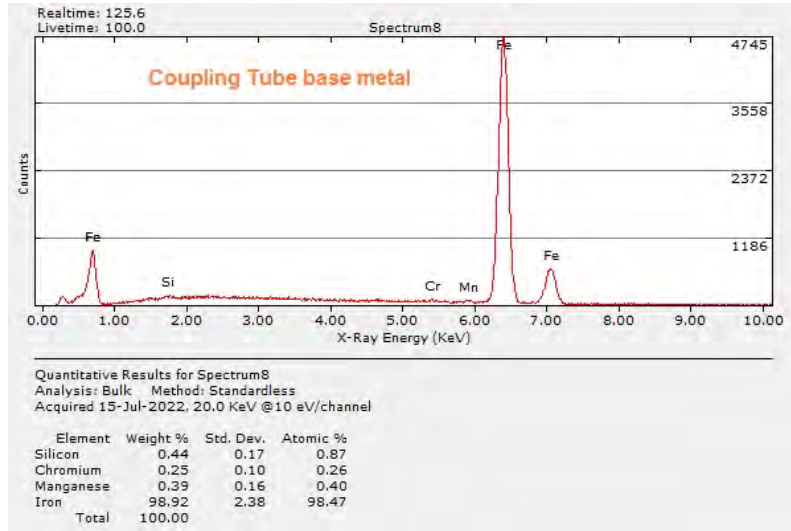
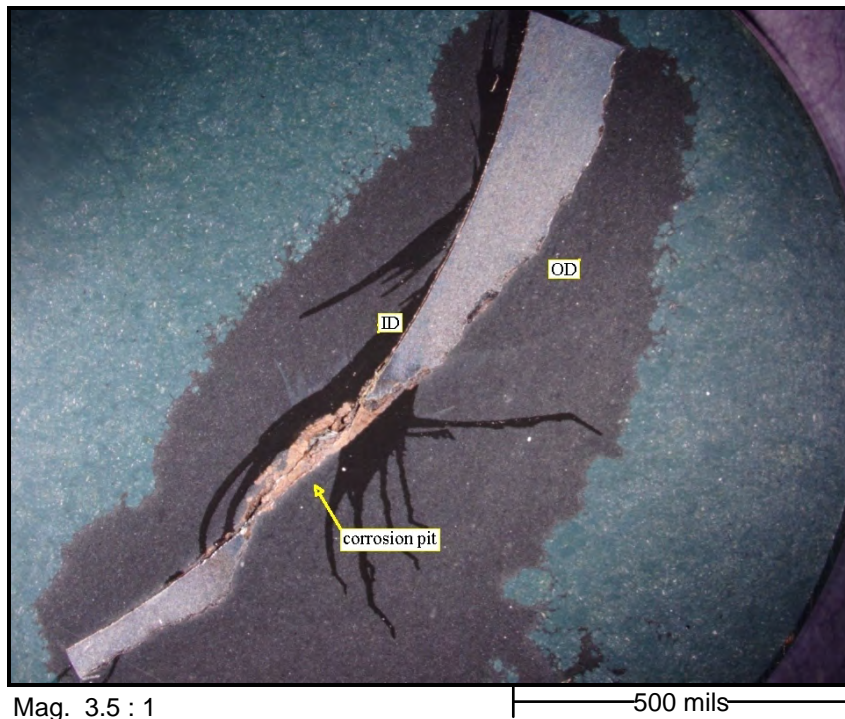
Figure 88:

The cut surface of the segment, Figure 88, was analyzed and the spectrogram is in Figure 89 which displayed predominantly iron (~99 wt.%) with trace levels of silicon, chromium and manganese. This reflects the composition of the tube material which is a carbon steel. No quantitative chemical analysis was deemed necessary to confirm the material type.

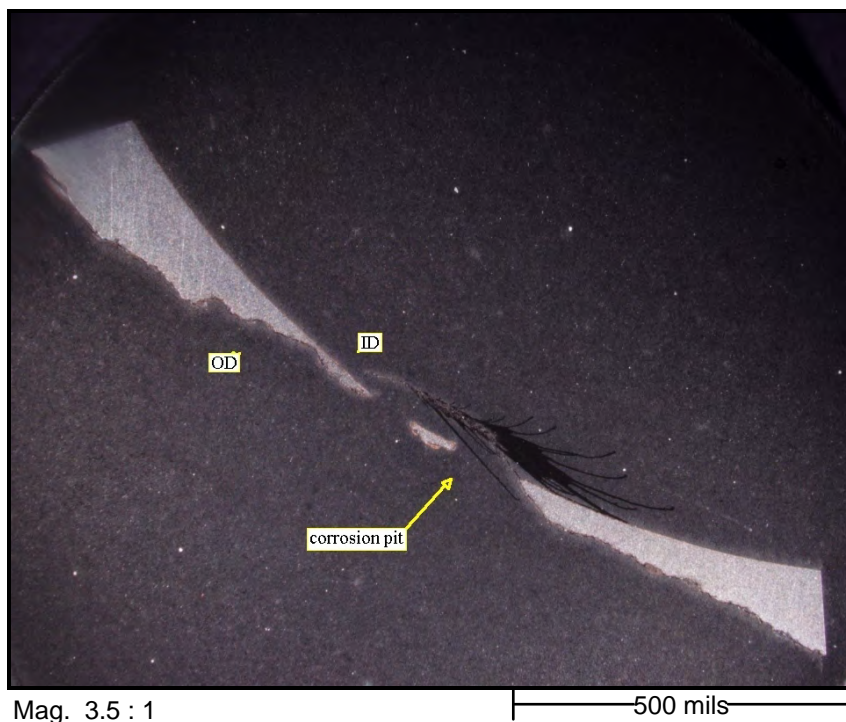
Figure 92: 4 o'clock: An overall view of the mounted cross-section. Note general corrosion on the OD. On the ID a reddish coating layer is present; no corrosion on the ID.

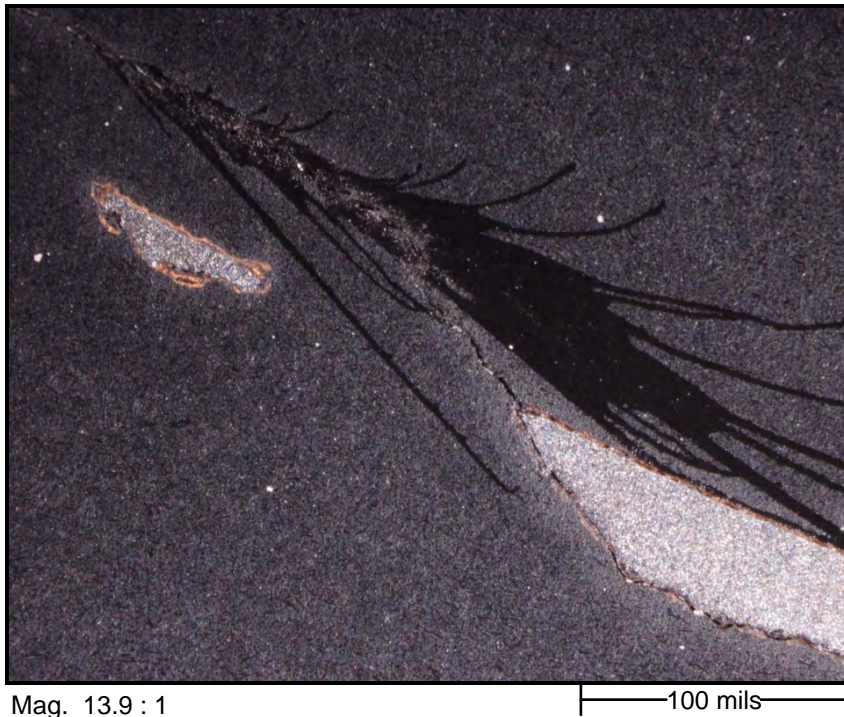
Figure 93: 7 o'clock: An overall view of the mounted cross-section.

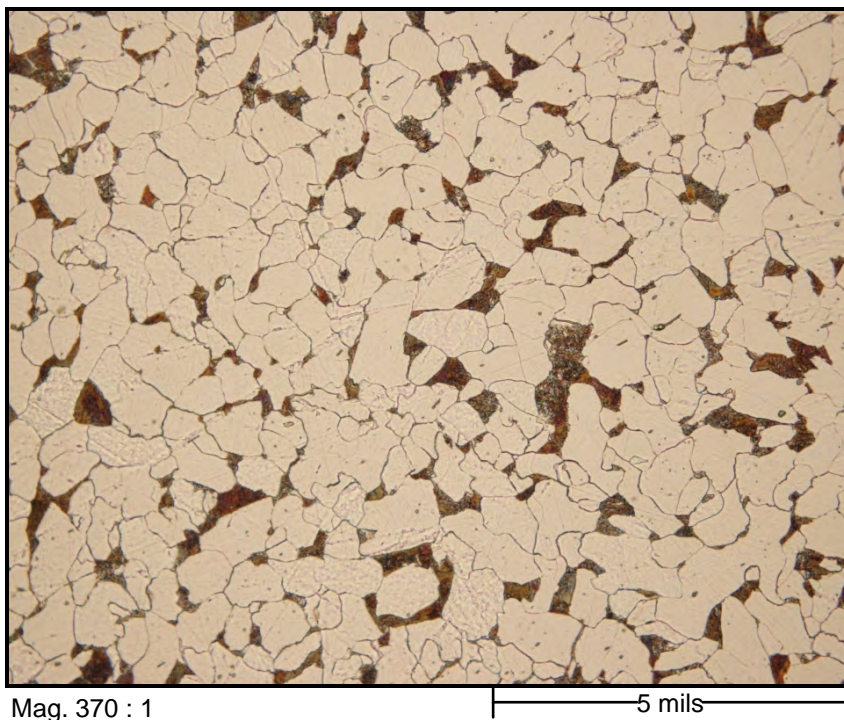
Figure 99: Mount at 4 o'clock: the view shows the opposite edge of the through wall corrosion pit. A higher magnification view of the previous image showing the microstructure.

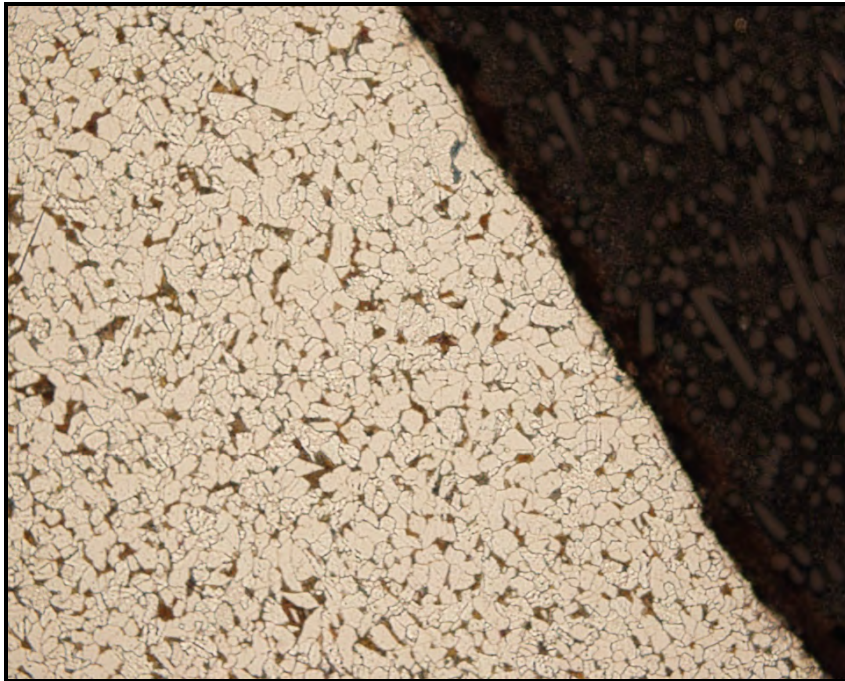
Figure 104: Mount at 7 o'clock: the view shows general corrosion attack on the OD.
